# COVID-19 PRODUCTIVITY REPORT March – June 2020

Citizens Advisory Committee August 19, 2020 Agenda Item #8

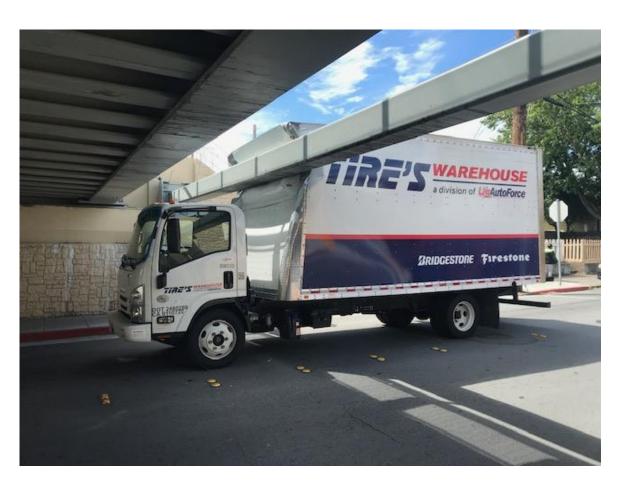
#### Crash Beam Strike At Tilton Ave.

- This is what a bad Friday really looks like...
- Expect the unexpected when working around the railroad
