Caltrain EMU Update

Citizens Advisory Committee May 20, 2020 Agenda Item #8

Caltrain is procuring 19, 7-Car Trainsets

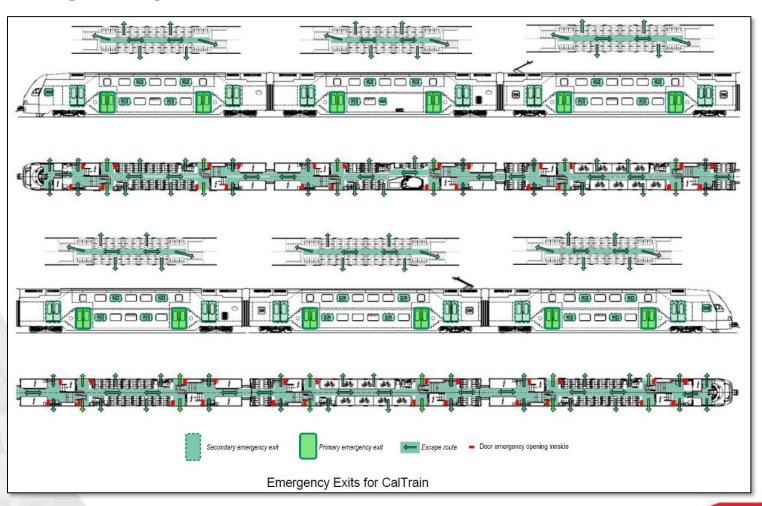
Emergency Exits

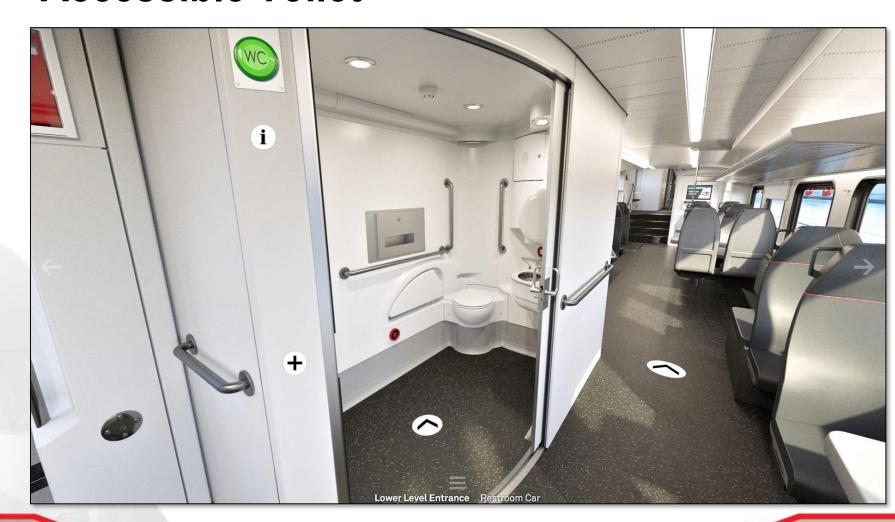
Accessible Toilet

- Passenger emergency intercom
- Emergency brake lever
- Emergency exit windows both levels
- Automatic passenger counter
- Accessible toilet ("C" Car)
- Bike storage in bike cars
- Passenger Information Display (Destinations)
- Passenger Brochures
- Public Announcement System
- Under-seat electrical outlets
- Interior LED lighting and temperature control
- Passenger WiFi provisions

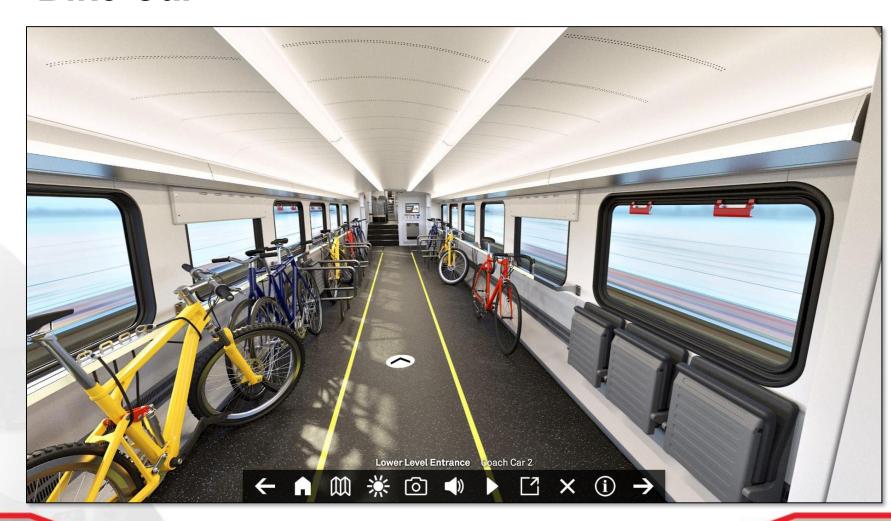
Bike Car

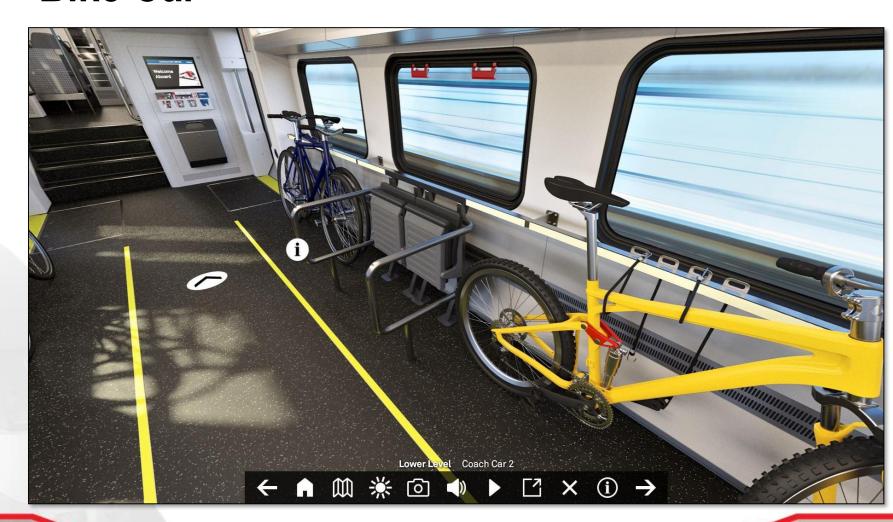
Bike Car

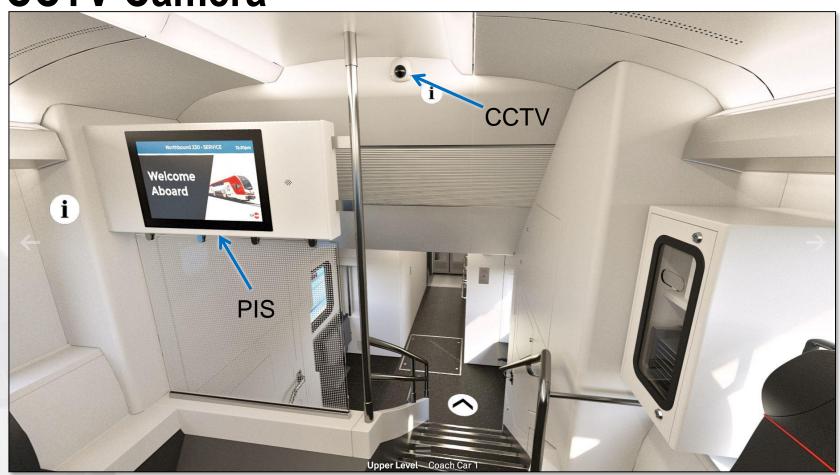
Passenger Information Display (PIS) and CCTV Camera

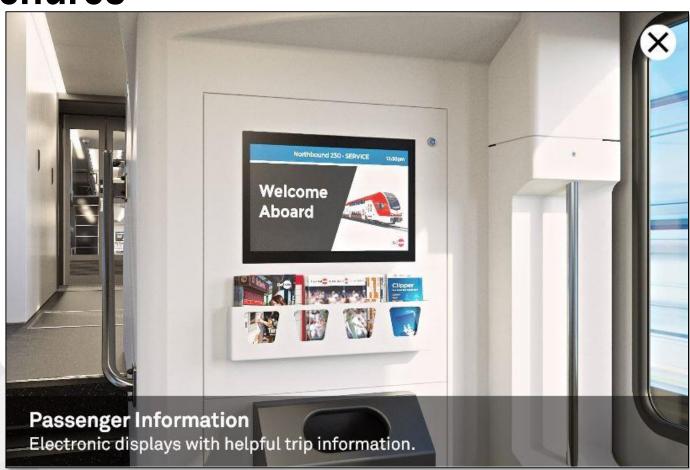
Passenger Information Display and Brochures

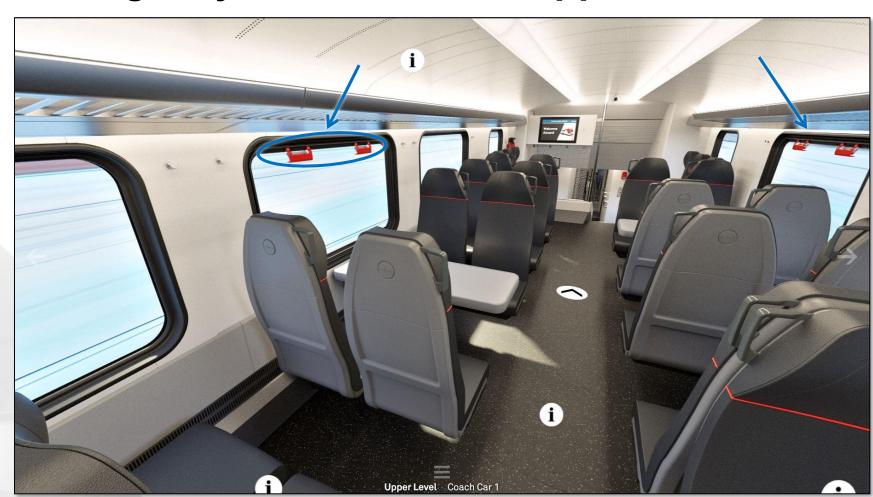
Emergency Exit Window – Upper Level

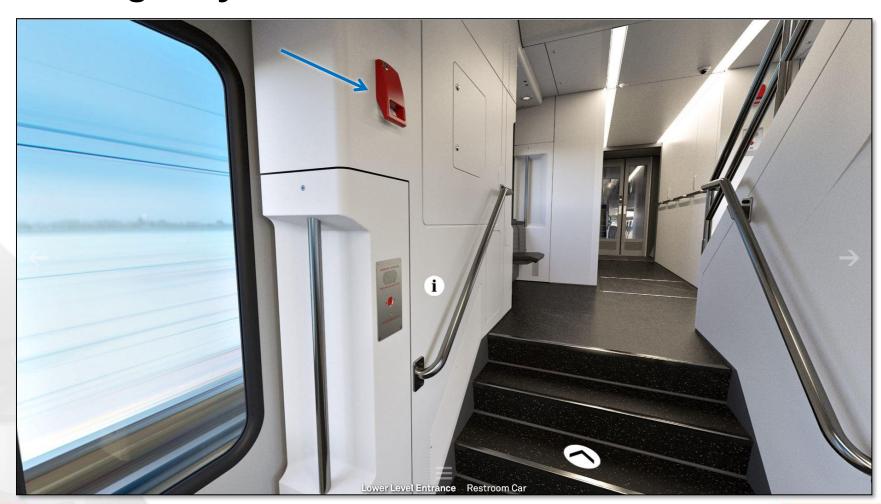
Emergency Brake Lever

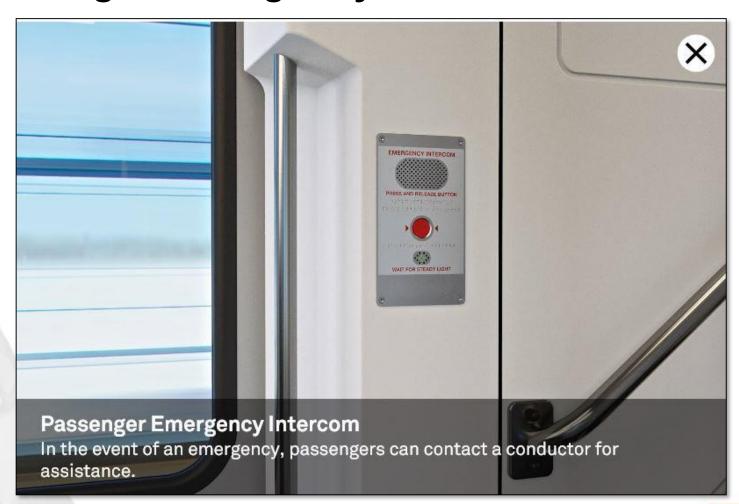
Passenger Emergency Intercom

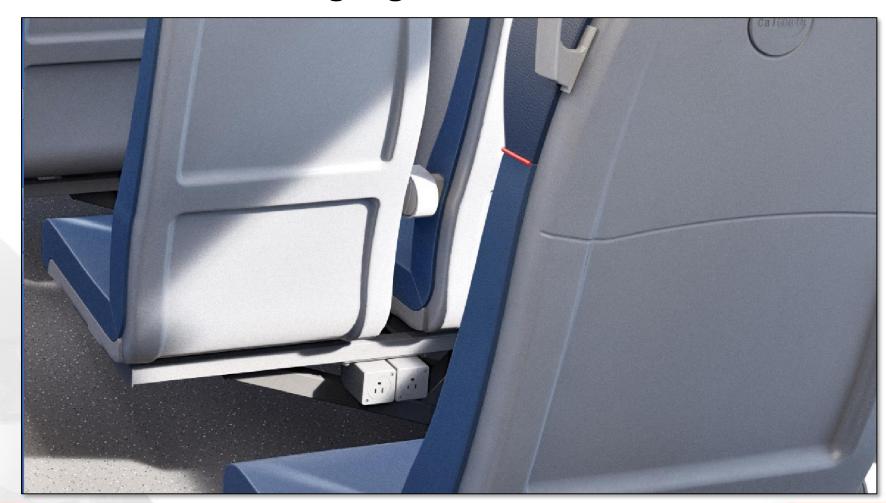
Underseat Charging Outlets

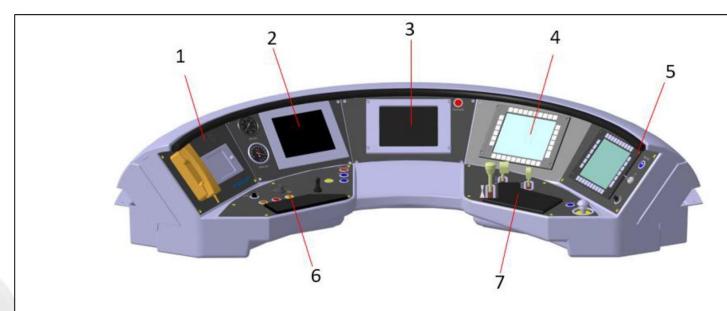
Figure 1: Operator desk

- 1 Communication panel
- 2 Passenger information System and gauges for brake pipe and main air pressure
- 3 Positive Train Control (PTC)
- 4 Diagnostic and vehicle status (TOD I)
- 5 Train operation (TOD II)
- 6 Train control panel
- 7 Drive operation control panel

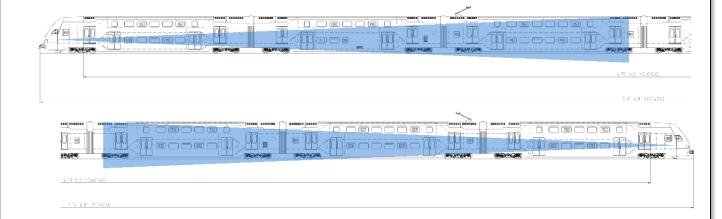
REAR VIEW CAMERA

Type: Full HD Camera

Resolution 1920x1080

Angle approx. 15 Grad

Distance: 220 feet

Sensor 1/3 inch CMOS

Light sensibility 0.2 lux

Housing metal/glassfibre Ethernet PoE /100Mbit

CONCEPT

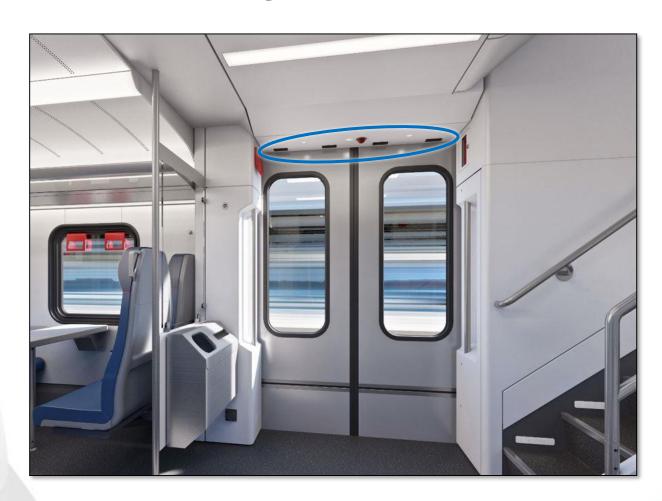
Automatic Passenger Counter

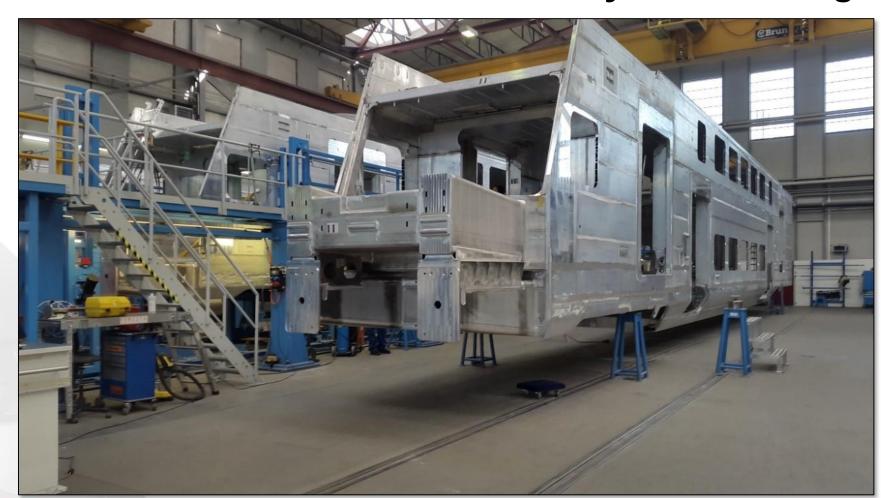
Car Shells in Switzerland Ready for Painting

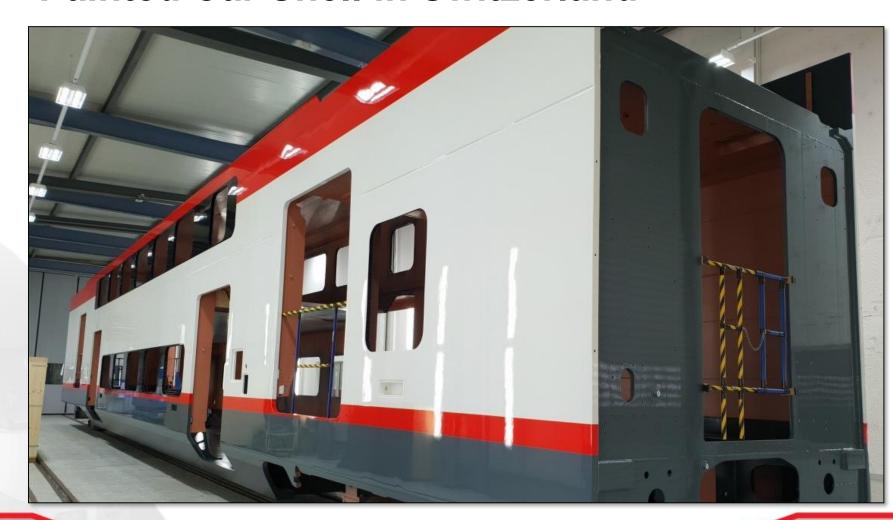
Painted Car Shell in Switzerland

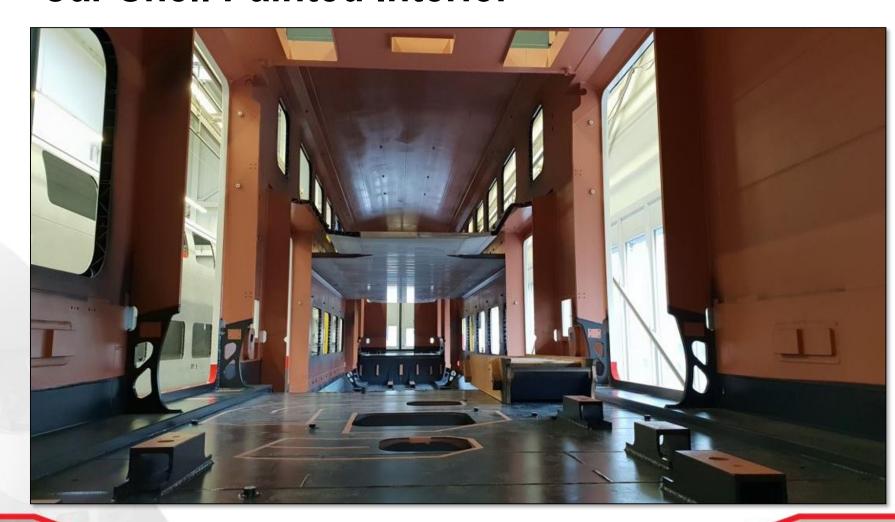
Car Shell Painted Interior

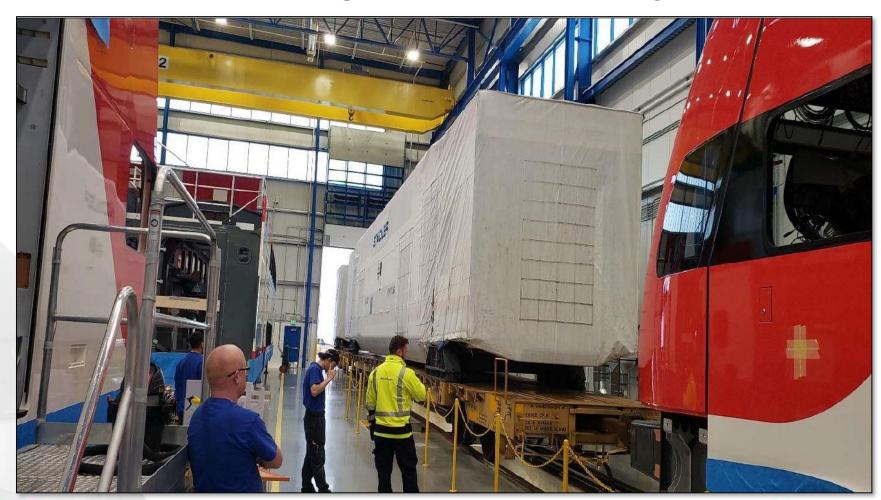
Car Shell Arriving In Salt Lake City

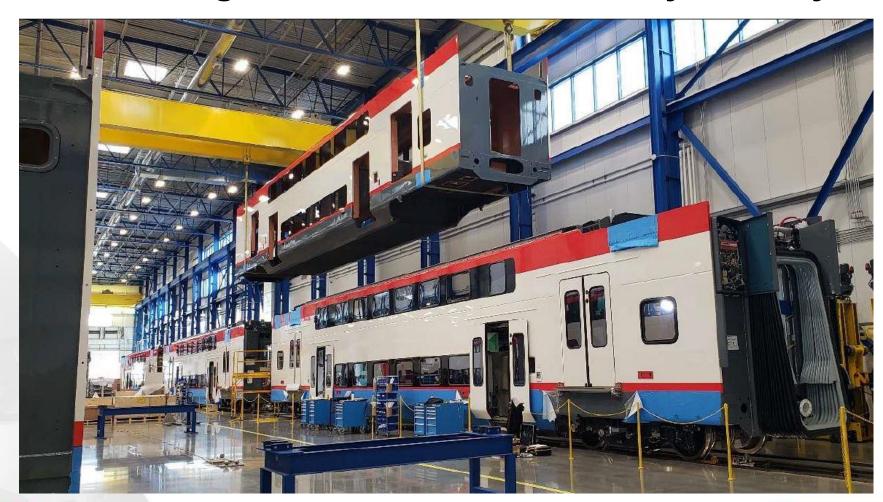
Cars Being Moved in Salt Lake City Facility

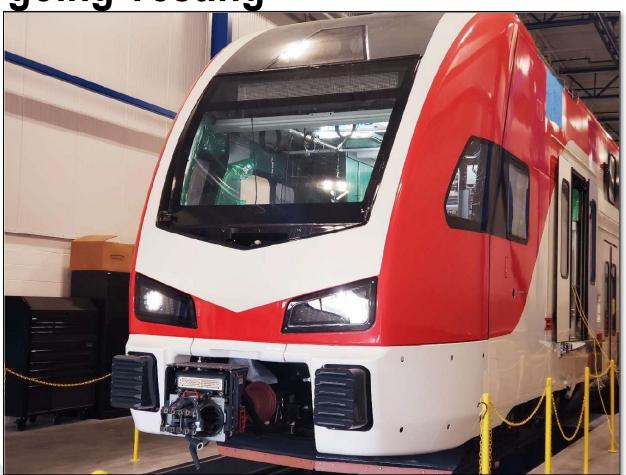
Trainset No. 1 in Salt Lake City

Undergoing Testing

- Trainset No. 1 Assembly Nearing Completion and Being Prepared for Testing in Salt Lake City
- Trainset No. 2 4 in various stages of completion in Salt Lake City
- Trainset No. 1 to commence testing in Railcar Testing facility in Pueblo,
 Colorado Fall of '2020. Testing Duration 7 months
- First Trainset to be delivered to Caltrain Spring of '2021.

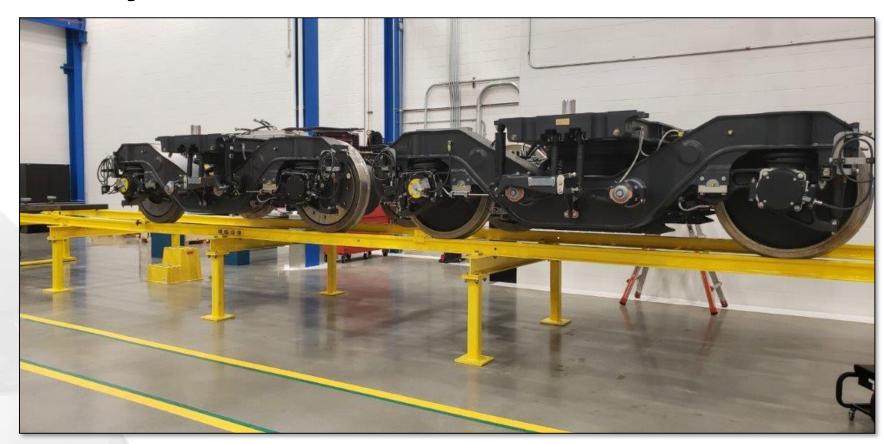
Trucks (bogies) Assembled in Salt Lake City Ready for Installation Under a Car

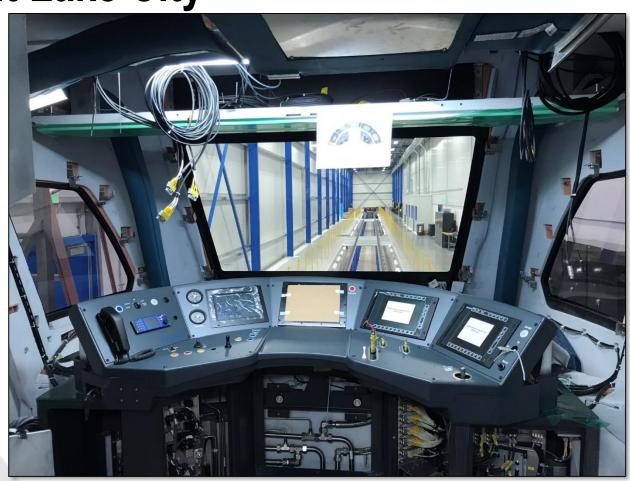
Cab Console Under Construction in Salt Lake City

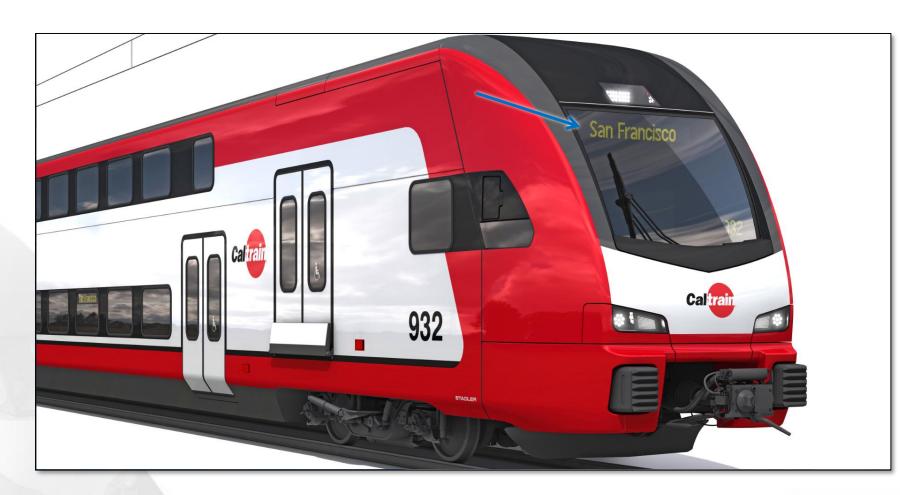
Front Destination Sign

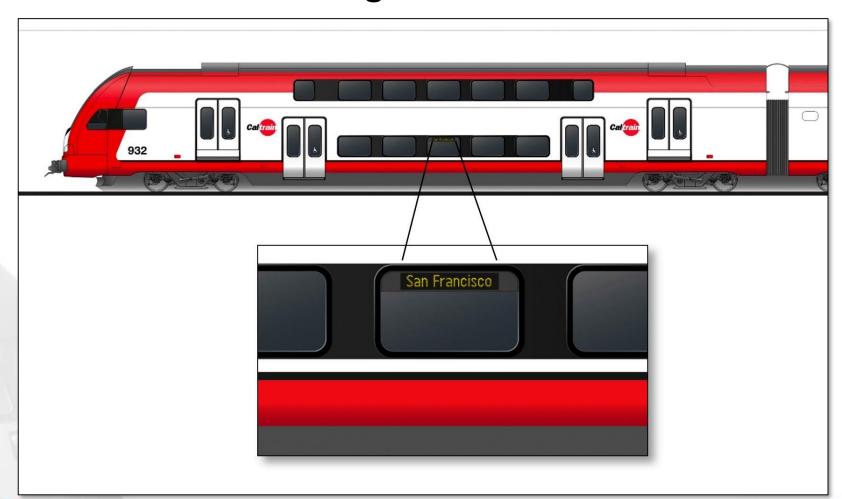
Side Destination Sign
