Safety Highlights

Engineering

Maintenance of Way

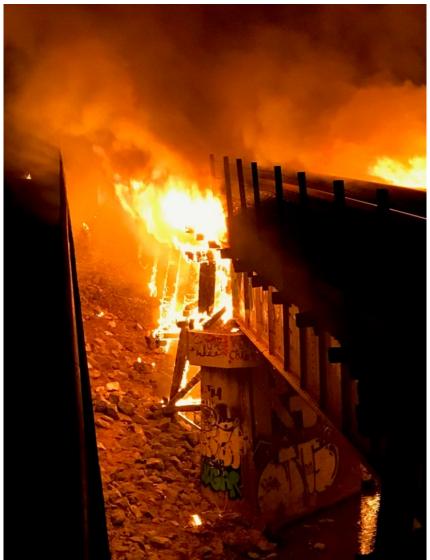
The Guadalupe River main track 1 (MT1) bridge in San Jose caught on fire and was reported at 3:25 a.m. on the morning of November 01, 2017; San Jose Fire Department reported that the likely cause was the result of a homeless encampment fire. MT2 track on a separate and adjacent railroad bridge was inspected and reopened for service at 5:10AM. MT1 track was inspected and reopened for service at 10:31AM. The Guadalupe River bridge replacement project is currently at 30% design and is the next bridge in the bridge program planned for replacement.

Bridge on fire

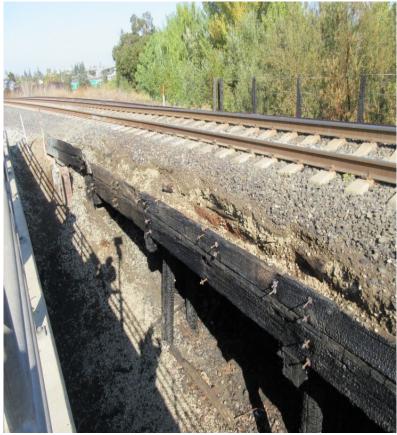
Bridge after fire and prior to repairs

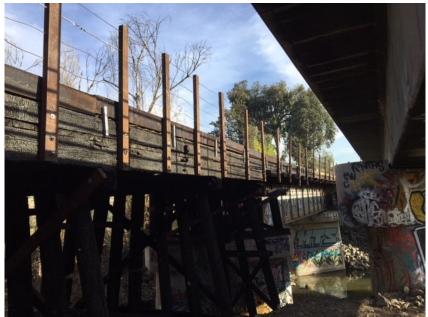
Bridge with new hand railing and cable rope installed.

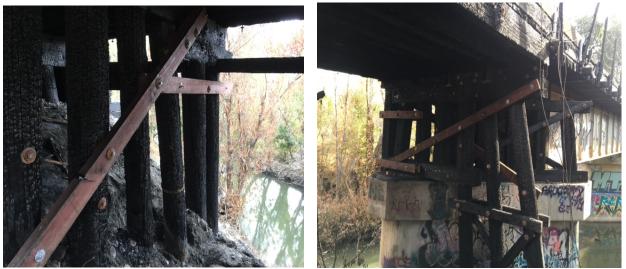
Bridge with new cross bracing installed.

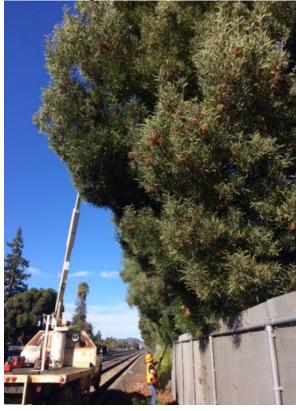
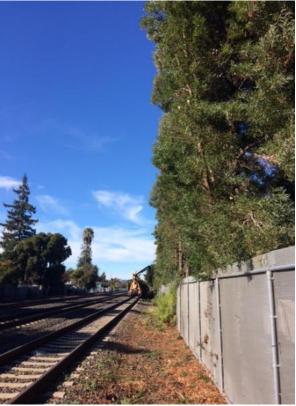
Vegetation removal and tree trimming adjacent to East and West Controlled Sidings(MP 26.7 – 27.0)

Before

After

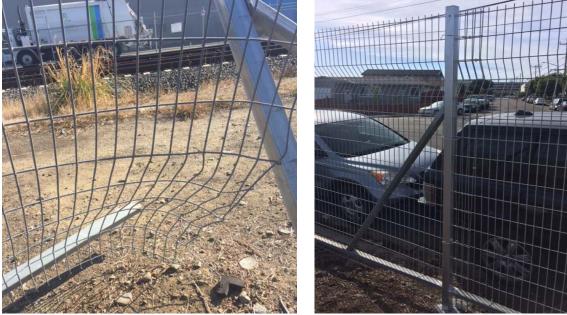
Multiple fence repairs along right of way due to vehicle strikes and vandalism.

Before

After

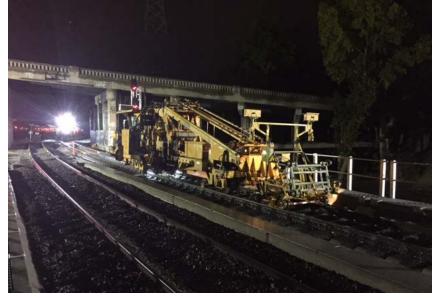
• Los Gatos Creek Bridge track surfacing support for UPRR

During
