Safety Highlights

Engineering

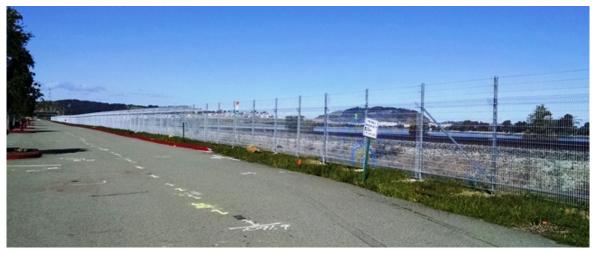
Caltrain continued installation of fence along the corridor to prevent individuals crossing or walking along tracks where an individual could be struck by a train.

The fence now limits crossing tracks at many locations that people before used for short cuts. These short cuts posed the potential for an individual to be hit by a train traveling at speeds up to 79 mph. Safety is always a priority at Caltrain.

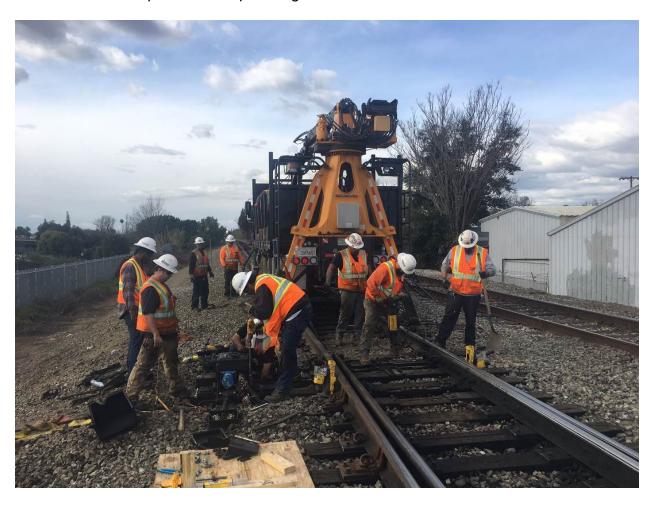
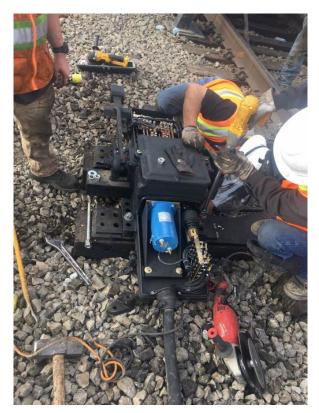
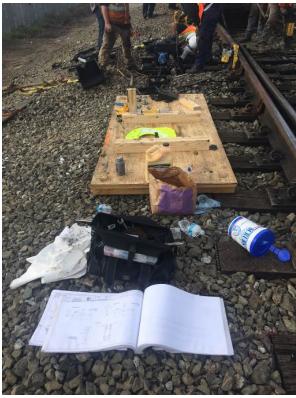
After

Replaced both signal & track components at Control Point Mack north of Tamien Station. For safety purposes, a time work window was established to allow two groups to work together: one to change the power switch machine and the other to change two Head Block Ties, which provide the foundation. Maintaining crossovers such as this one is essential to provide safe passenger service.

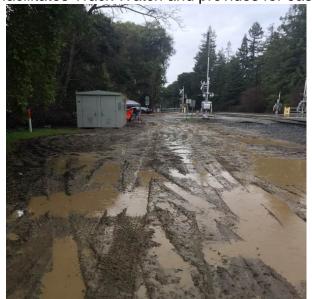
At the request of the Palo Alto Police to provide easier vehicular access to the area, additional ballast was added south of the grade crossing at Alma Avenue. This facilitates Track Watch and provides for easier access by TASI personnel.

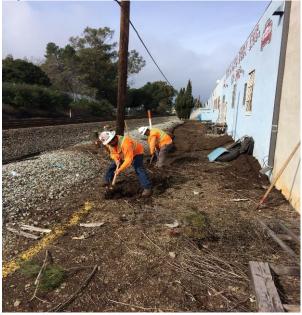
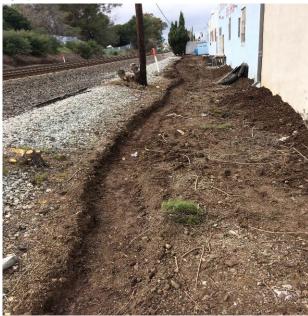
Before After

To help lessen the risk of flooding adjacent private properties, the vegetation along our right of way was removed and a "V" ditch was cut to channel water away from the

adjacent buildings, which are located in Belmont.

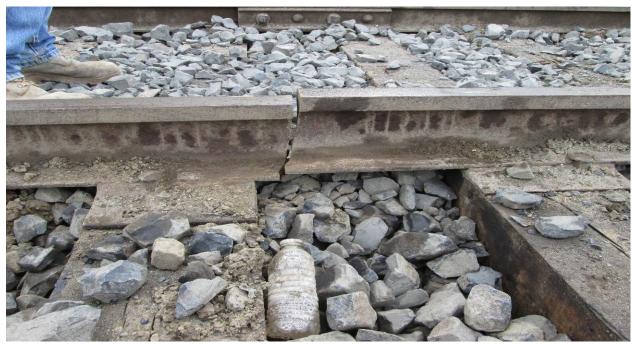
Track safety inspection resulted in finding a broken rail in the South San Francisco yard:

Broken rail found on Track 3 in South San Francisco Yard

The track rail was repaired:

new ties and rail replaced

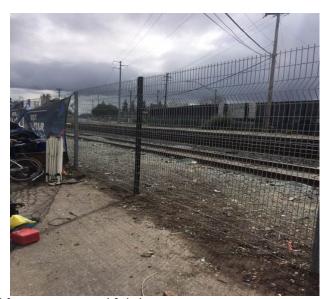
Replaced damaged fence posts and fabric

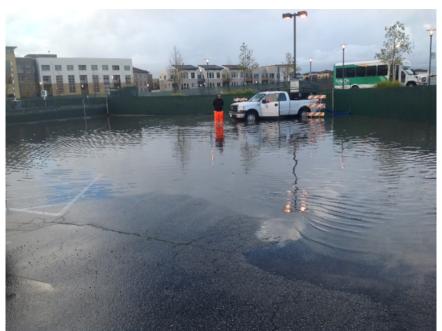
Continued pumping water out of Hillsdale east side parking; Bay Meadows contractor construction work has created a problem at this leased area

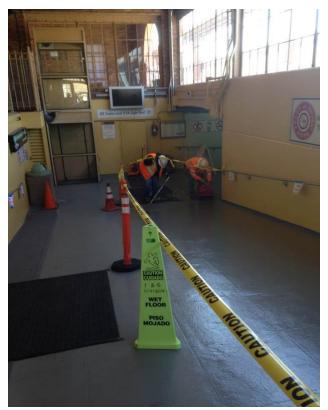
State of Good Repair work at San Jose Diridon ramp, sand is added to paint to prevent slips

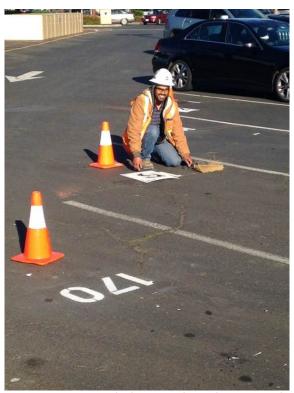
Continuous improvement - repainting numbers in our stations' parking lots
