CONSOLIDATED SAFETY STUDY FOR CALTRAIN IN SANTA CLARA COUNTY

Executive Summary

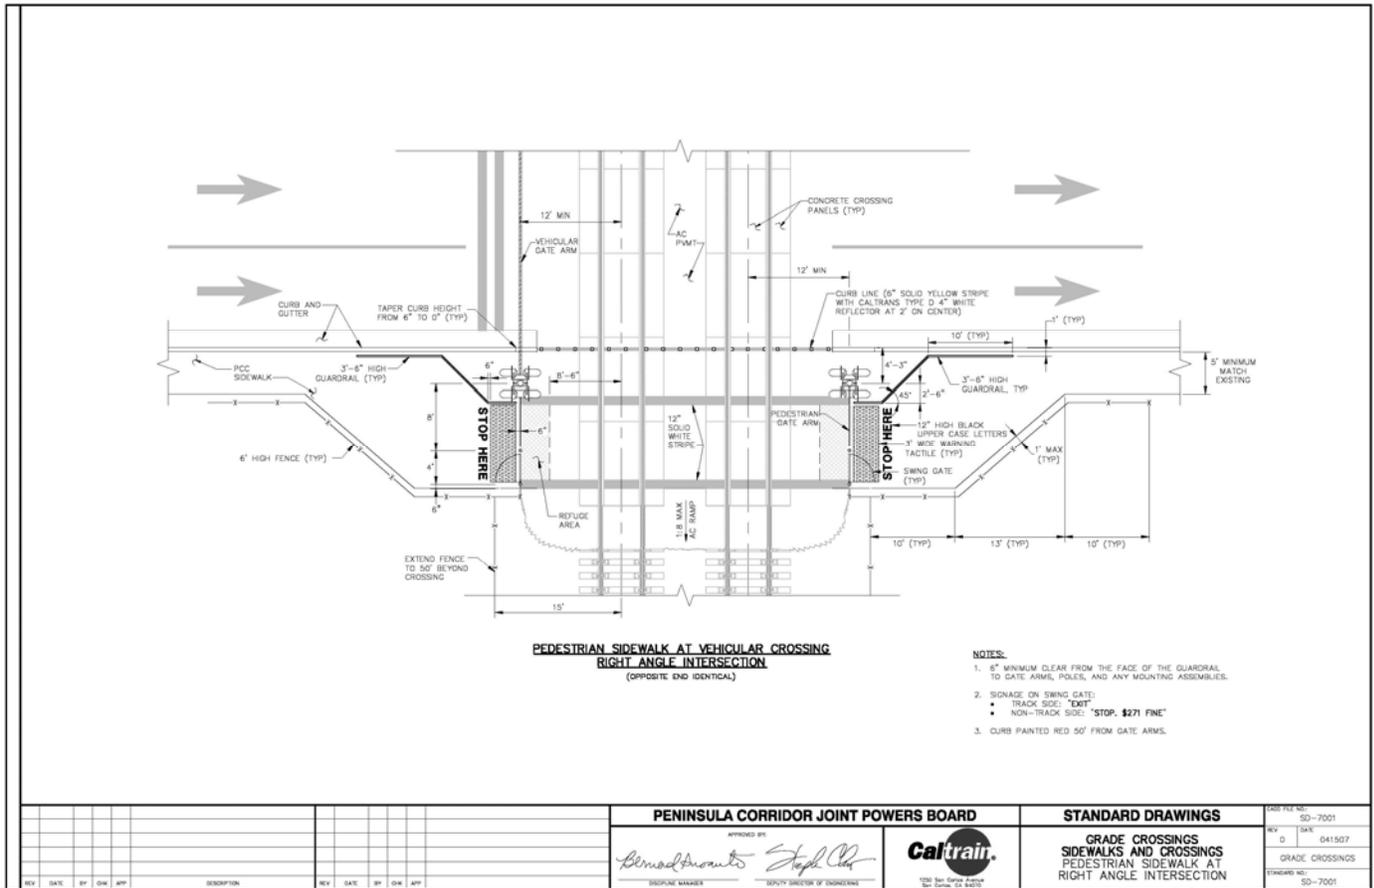
Figure 2: PCJPB Grade Crossing Standard

In many locations, wear and tear has made the roadway and sidewalk approaches to the crossing not very pedestrian or bicycle friendly. Uneven crossing surfaces, potholes and gaps between the rails cause hazards for pedestrians as well as for people with disabilities. To remedy these problems, sidewalk approaches should be restored to minimum ADA standards (5% maximum grade, or 8.33% grade if less than 30' run) and be built up to the track way to allow for a smooth transition up and over the tracks.

Pedestrian tactile warning treatment in sidewalks adjacent to a track way crossing is another form of improving pedestrian safety. The purpose of the tactile warning is to identify for pedestrians a safe stopping location and safe refuge area that is outside the train’s dynamic envelope. When crossing the tracks, the tactile warning treatment provides suitable warning to pedestrians that they are entering an area of increased risk, and again when they are exiting the risk envelope on the other side. This is also clearly shown in the PCJPB grade crossing standard in Figure 2.

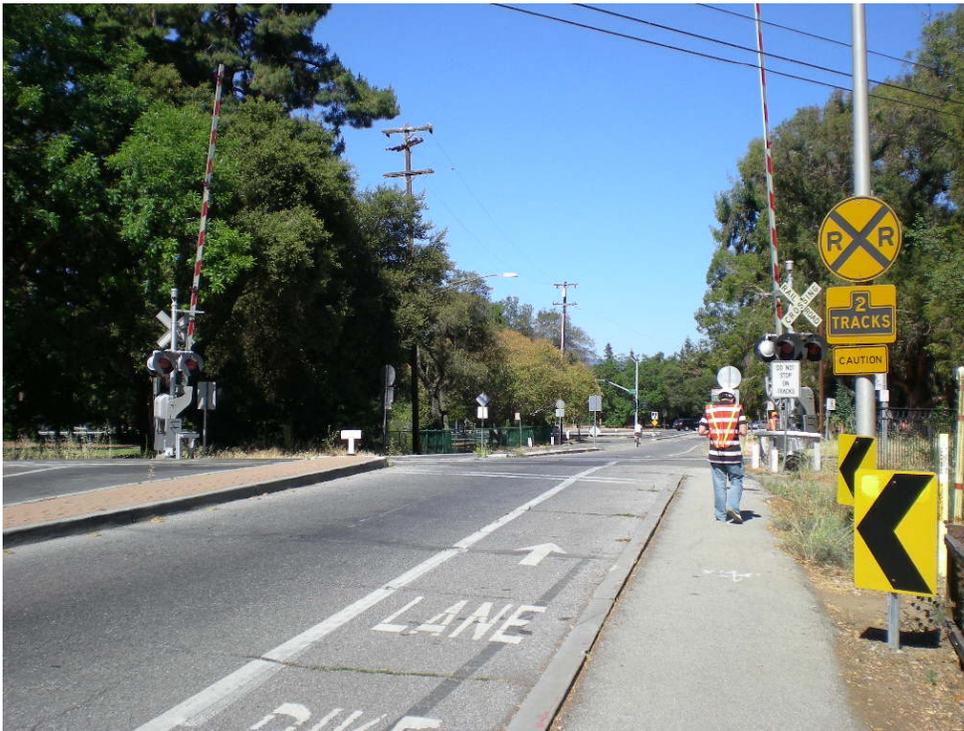
ALMA STREET

<p><u>Northwest Quadrant</u></p> <ul style="list-style-type: none"> • No Pedestrian Gate • No Swing Gate • Concrete path off to the side of the road. 	<p><u>Northeast Quadrant</u></p> <ul style="list-style-type: none"> • No Pedestrian Gate • No Swing Gate • No RXR Pavement Markings
<p><u>Southwest Quadrant</u></p> <ul style="list-style-type: none"> • No Pedestrian Gate • No Existing Sidewalk • No Swing Gate 	<p><u>Southeast Quadrant</u></p> <ul style="list-style-type: none"> • No Pedestrian Gate • No Existing Sidewalk • No Swing Gate

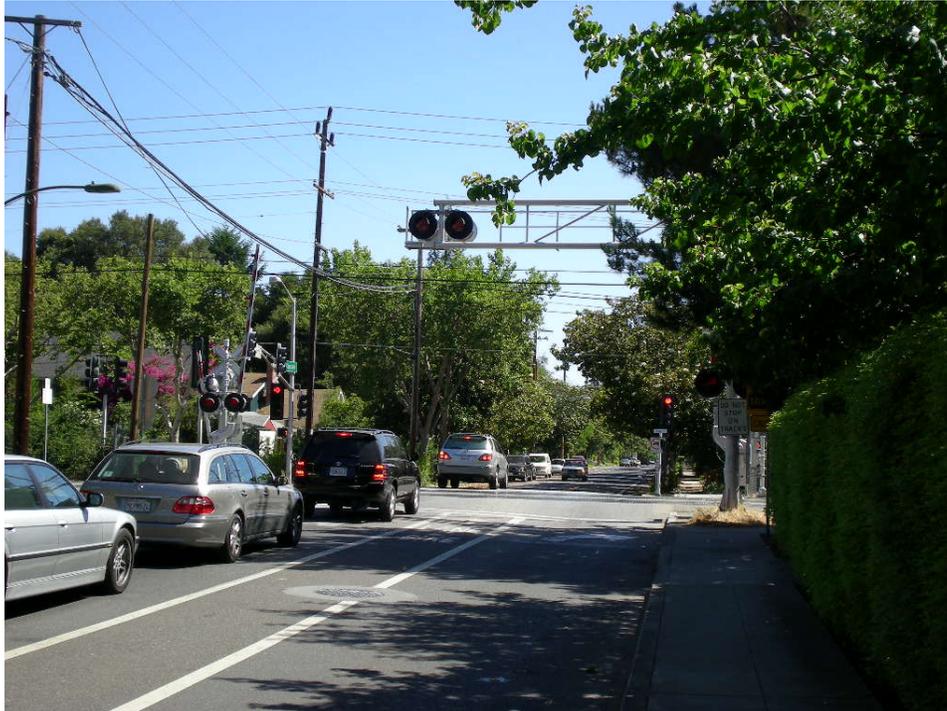
CHURCHILL AVENUE

<p style="text-align: center;"><u>Northwest Quadrant</u></p> <ul style="list-style-type: none"> ● No Warning Tactiles ● No Swing Gate ● No Medians 	<p style="text-align: center;"><u>Northeast Quadrant</u></p> <ul style="list-style-type: none"> ● No Warning Tactiles ● No Swing Gate ● No Medians ● No Right Turn LED Sign
<p style="text-align: center;"><u>Southwest Quadrant</u></p> <ul style="list-style-type: none"> ● No Warning Tactiles ● No Swing Gates ● No Medians 	<p style="text-align: center;"><u>Southeast Quadrant</u></p> <ul style="list-style-type: none"> ● No Warning Tactiles ● No Swing Gates ● No Medians

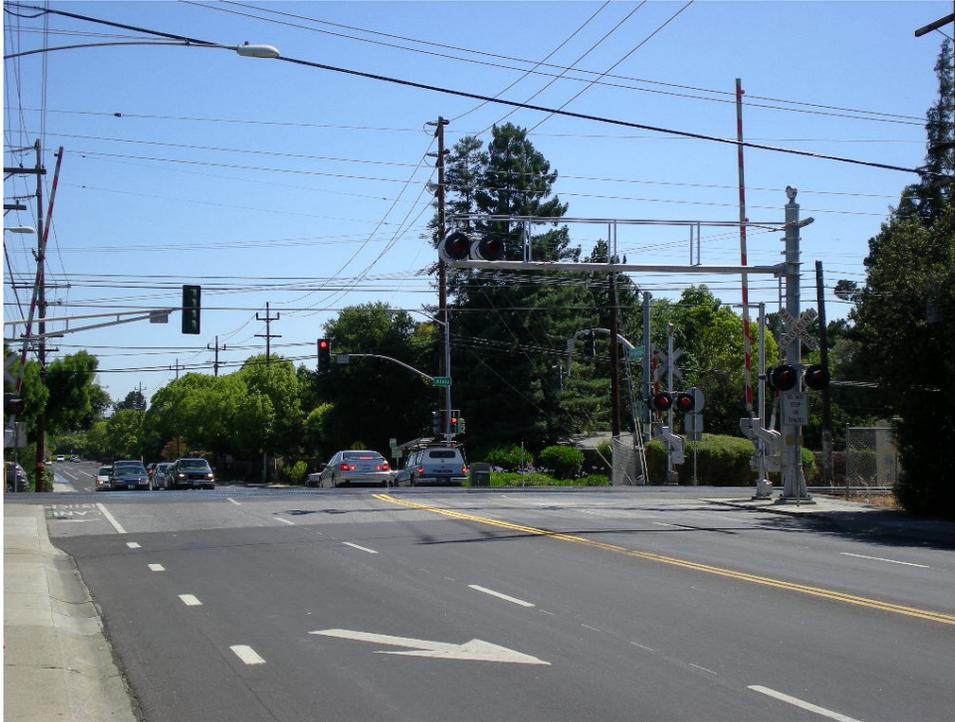
EAST MEADOW DRIVE

<p style="text-align: center;"><u>Northwest Quadrant</u></p> <ul style="list-style-type: none"> ● No Warning Tactiles ● No Swing Gate ● No Medians 	<p style="text-align: center;"><u>Northeast Quadrant</u></p> <ul style="list-style-type: none"> ● No Warning Tactiles ● No Swing Gate ● No Medians ● No Right Turn LED Sign
<p style="text-align: center;"><u>Southwest Quadrant</u></p> <ul style="list-style-type: none"> ● No Warning Tactiles ● No Swing Gates ● No Medians 	<p style="text-align: center;"><u>Southeast Quadrant</u></p> <ul style="list-style-type: none"> ● No Warning Tactiles ● No Swing Gates ● No Medians

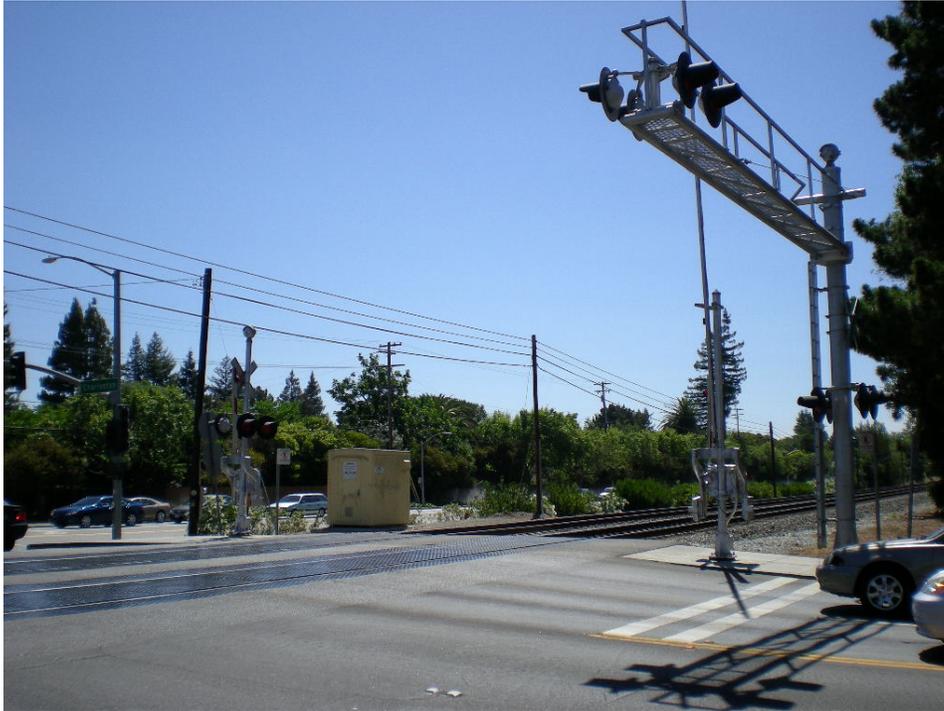
CHARLESTON ROAD

<p style="text-align: center;"><u>Northwest Quadrant</u></p> <ul style="list-style-type: none"> ● No Warning Tactiles ● No Swing Gate ● Advanced Warning Sign not visible due to vegetation 	<p style="text-align: center;"><u>Northeast Quadrant</u></p> <ul style="list-style-type: none"> ● No Warning Tactiles ● No Swing Gate ● No Medians ● No Right Turn LED Sign
<p style="text-align: center;"><u>Southwest Quadrant</u></p> <ul style="list-style-type: none"> ● No Warning Tactiles ● No Swing Gates ● No Medians 	<p style="text-align: center;"><u>Southeast Quadrant</u></p> <ul style="list-style-type: none"> ● No Warning Tactiles ● No Swing Gates ● No Medians

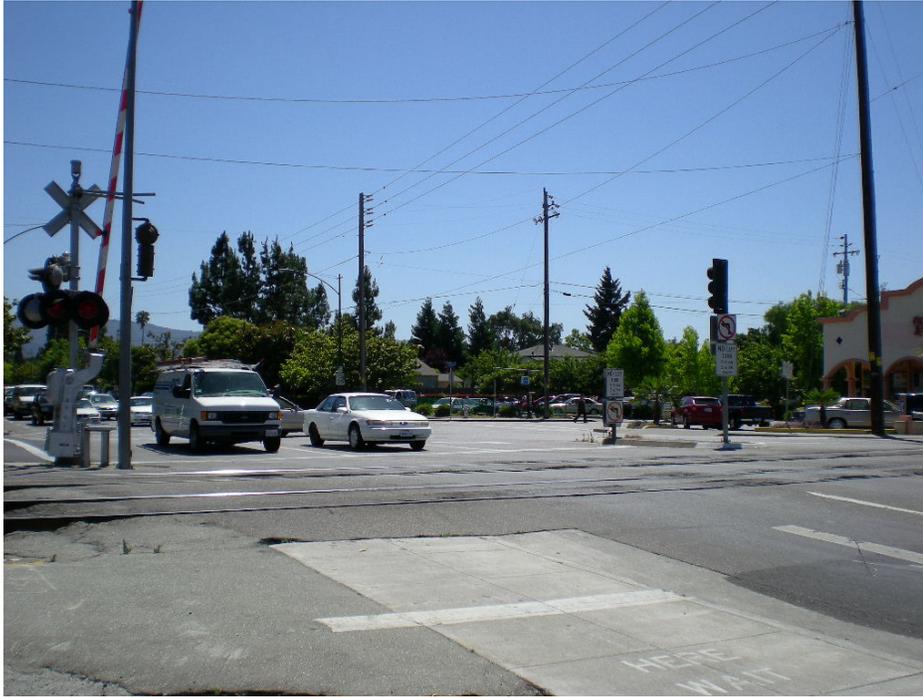
RENGSTORFF AVENUE

<p style="text-align: center;"><u>Northwest Quadrant</u></p> <ul style="list-style-type: none"> ● No Pedestrian Gate ● No Swing Gate ● No Warning Tactiles 	<p style="text-align: center;"><u>Northeast Quadrant</u></p> <ul style="list-style-type: none"> ● No Pedestrian Gate ● No Swing Gate ● No Warning Tactiles
<p style="text-align: center;"><u>Southwest Quadrant</u></p> <ul style="list-style-type: none"> ● No Pedestrian Gate ● No Swing Gates ● No Medians 	<p style="text-align: center;"><u>Southeast Quadrant</u></p> <ul style="list-style-type: none"> ● No Pedestrian Gate ● No Swing Gates ● No Medians ● AC Ramp crumbling

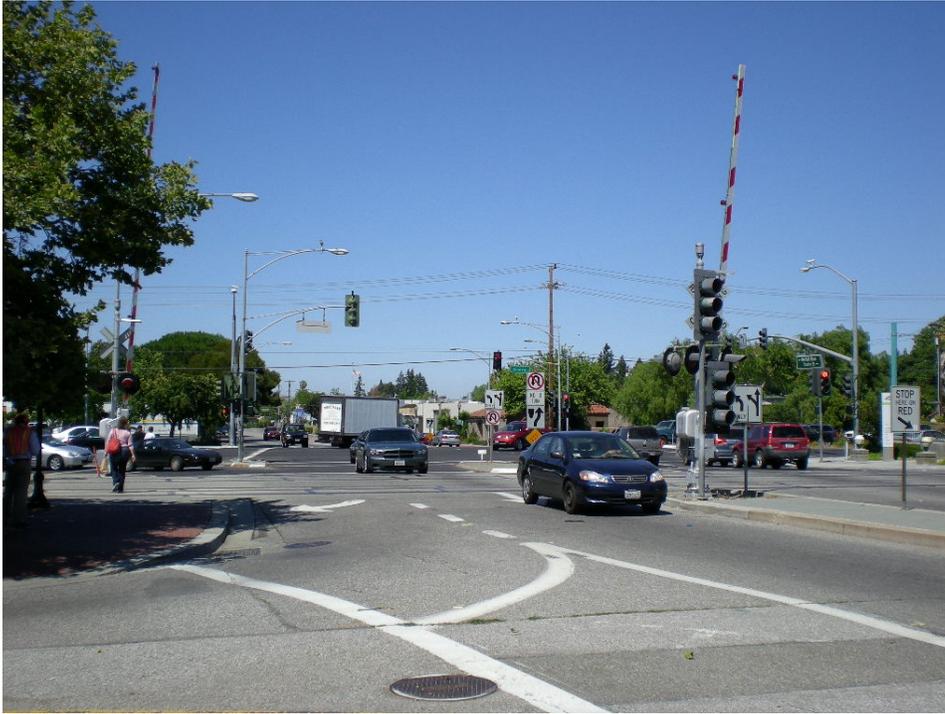
CASTRO STREET

<p style="text-align: center;"><u>Northwest Quadrant</u></p> <ul style="list-style-type: none"> ● No Pedestrian Gate ● No Swing Gate ● No Warning Tactiles 	<p style="text-align: center;"><u>Northeast Quadrant</u></p> <ul style="list-style-type: none"> ● No Pedestrian Gate ● No Swing Gate ● No Warning Tactiles
<p style="text-align: center;"><u>Southwest Quadrant</u></p> <ul style="list-style-type: none"> ● No Warning Tactiles ● No Swing Gates 	<p style="text-align: center;"><u>Southeast Quadrant</u></p> <ul style="list-style-type: none"> ● No Warning Tactiles ● No Swing Gates

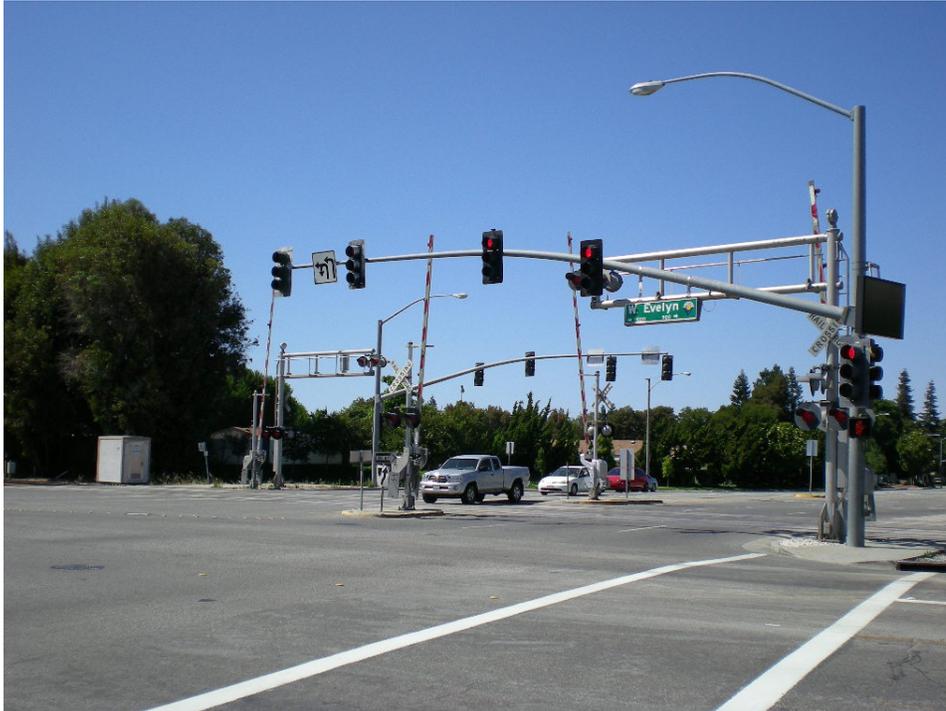
MARY AVENUE

<p style="text-align: center;"><u>Northwest Quadrant</u></p> <ul style="list-style-type: none"> ● No Pedestrian Gate ● No Swing Gate ● No Warning Tactiles 	<p style="text-align: center;"><u>Northeast Quadrant</u></p> <ul style="list-style-type: none"> ● No Pedestrian Gate ● No Swing Gate ● No Warning Tactiles
<p style="text-align: center;"><u>Southwest Quadrant</u></p> <ul style="list-style-type: none"> ● No Pedestrian Gate ● No Swing Gates ● No Warning Tactiles 	<p style="text-align: center;"><u>Southeast Quadrant</u></p> <ul style="list-style-type: none"> ● No Pedestrian Gate ● No Swing Gates ● No Warning Tactiles

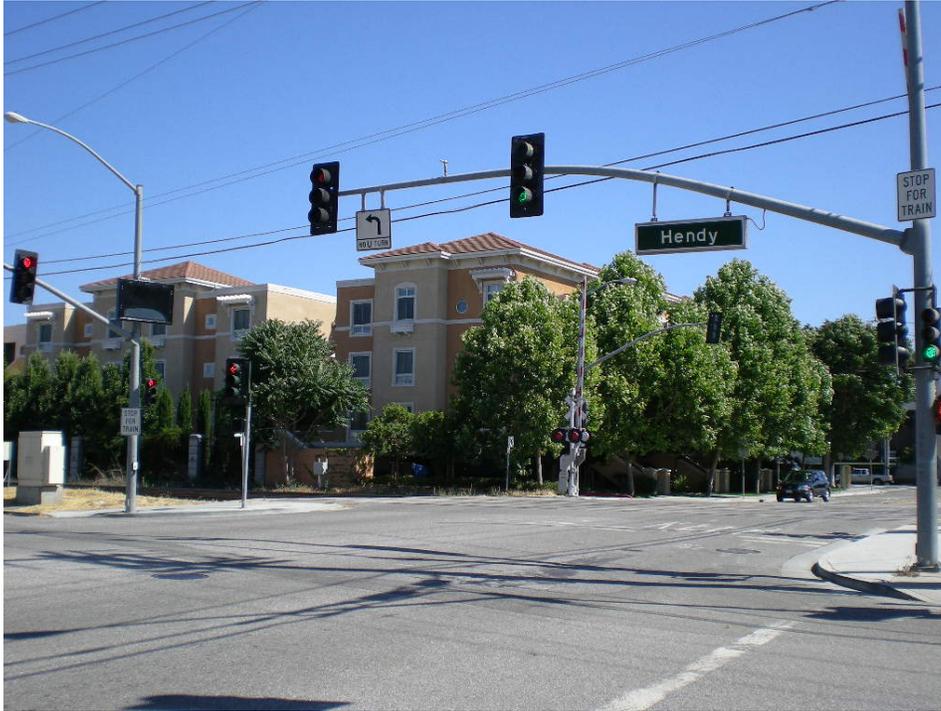
SUNNYVALE AVENUE

<p style="text-align: center;"><u>Northwest Quadrant</u></p> <ul style="list-style-type: none"> ● No Pedestrian Gate ● No Swing Gate ● No Warning Tactiles 	<p style="text-align: center;"><u>Northeast Quadrant</u></p> <ul style="list-style-type: none"> ● No Pedestrian Gate ● No Swing Gate ● No Warning Tactiles
<p style="text-align: center;"><u>Southwest Quadrant</u></p> <ul style="list-style-type: none"> ● No Pedestrian Gate ● No Swing Gates ● No Warning Tactiles 	<p style="text-align: center;"><u>Southeast Quadrant</u></p> <ul style="list-style-type: none"> ● No Pedestrian Gate ● No Swing Gates ● No Warning Tactiles

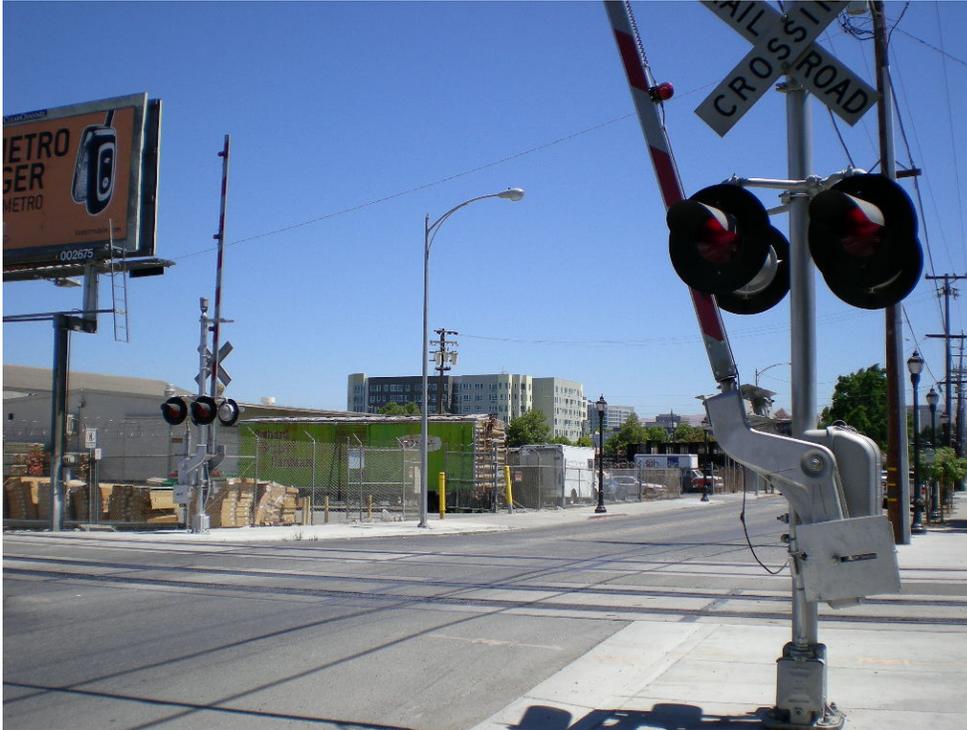
AUZERAIS AVENUE

<p style="text-align: center;"><u>Northwest Quadrant</u></p> <ul style="list-style-type: none"> ● No Pedestrian Gate ● No Swing Gate ● No Warning Tactiles 	<p style="text-align: center;"><u>Northeast Quadrant</u></p> <ul style="list-style-type: none"> ● No Pedestrian Gate ● No Swing Gate ● No Warning Tactiles
<p style="text-align: center;"><u>Southwest Quadrant</u></p> <ul style="list-style-type: none"> ● No Pedestrian Gate ● No Swing Gates ● No Warning Tactiles 	<p style="text-align: center;"><u>Southeast Quadrant</u></p> <ul style="list-style-type: none"> ● No Pedestrian Gate ● No Swing Gates ● No Warning Tactiles

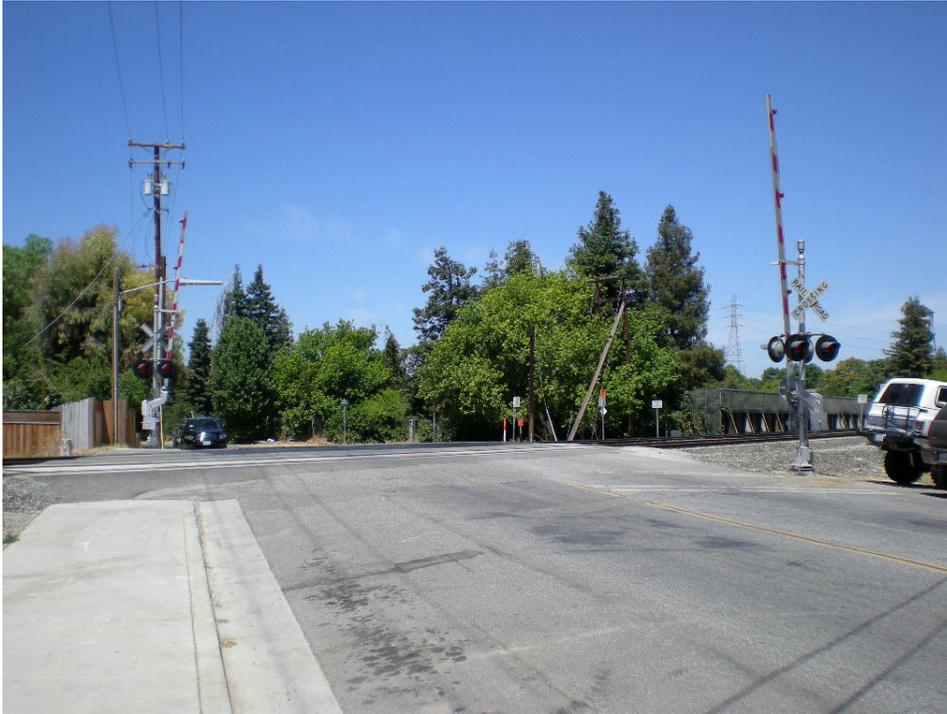
VIRGINIA AVENUE

<p style="text-align: center;"><u>Northwest Quadrant</u></p> <ul style="list-style-type: none"> ● No Pedestrian Gate ● No Swing Gate ● No Warning Tactiles 	<p style="text-align: center;"><u>Northeast Quadrant</u></p> <ul style="list-style-type: none"> ● No Pedestrian Gate ● No Swing Gate ● No Warning Tactiles
<p style="text-align: center;"><u>Southwest Quadrant</u></p> <ul style="list-style-type: none"> ● No Pedestrian Gate ● No Swing Gates ● No Warning Tactiles 	<p style="text-align: center;"><u>Southeast Quadrant</u></p> <ul style="list-style-type: none"> ● No Pedestrian Gate ● No Swing Gates ● No Warning Tactiles

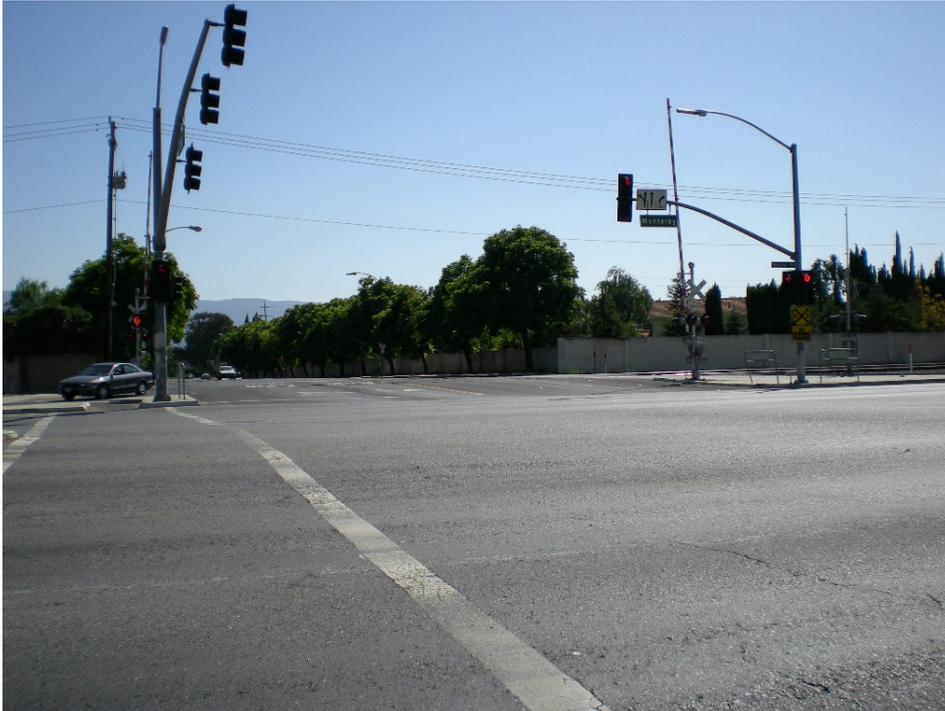
SKYWAY AVENUE

<p style="text-align: center;"><u>Northwest Quadrant</u></p> <ul style="list-style-type: none"> ● No Pedestrian Gate ● No Swing Gate ● No Warning Tactiles 	<p style="text-align: center;"><u>Northeast Quadrant</u></p> <ul style="list-style-type: none"> ● No Pedestrian Gate ● No Swing Gate ● No Warning Tactiles
<p style="text-align: center;"><u>Southwest Quadrant</u></p> <ul style="list-style-type: none"> ● No Pedestrian Gate ● No Swing Gates ● No Warning Tactiles 	<p style="text-align: center;"><u>Southeast Quadrant</u></p> <ul style="list-style-type: none"> ● No Pedestrian Gate ● No Swing Gates ● No Warning Tactiles

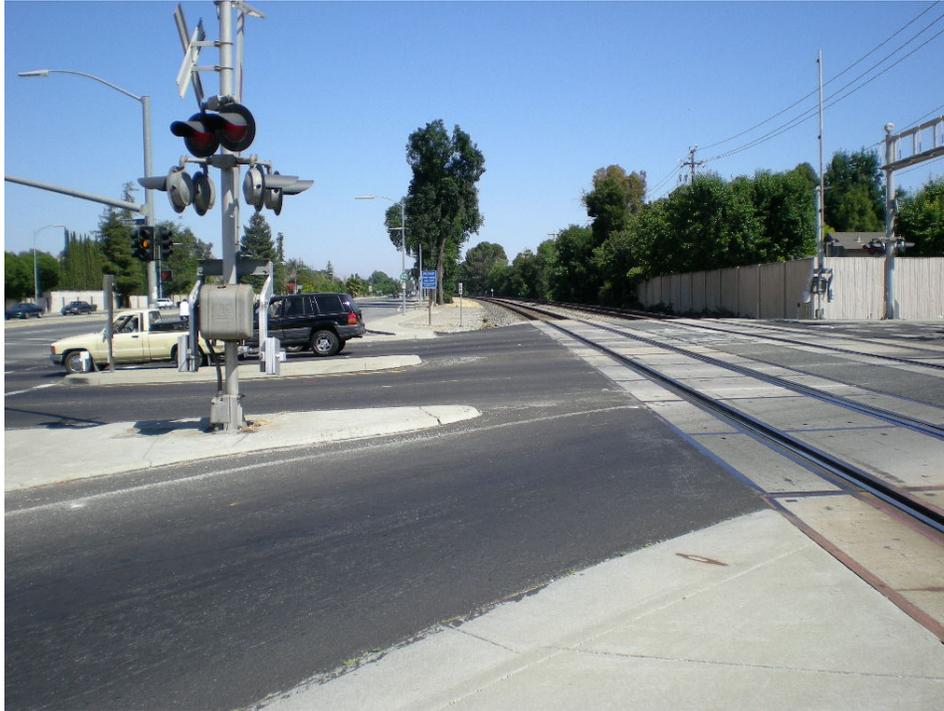
BRANHAM LANE

<p style="text-align: center;"><u>Northwest Quadrant</u></p> <ul style="list-style-type: none"> ● No Pedestrian Gate ● No Swing Gate ● No Warning Tactiles 	<p style="text-align: center;"><u>Northeast Quadrant</u></p> <ul style="list-style-type: none"> ● No Pedestrian Gate ● No Swing Gate ● No Warning Tactiles
<p style="text-align: center;"><u>Southwest Quadrant</u></p> <ul style="list-style-type: none"> ● No Pedestrian Gate ● No Swing Gates ● No Warning Tactiles 	<p style="text-align: center;"><u>Southeast Quadrant</u></p> <ul style="list-style-type: none"> ● No Pedestrian Gate ● No Swing Gates ● No Warning Tactiles

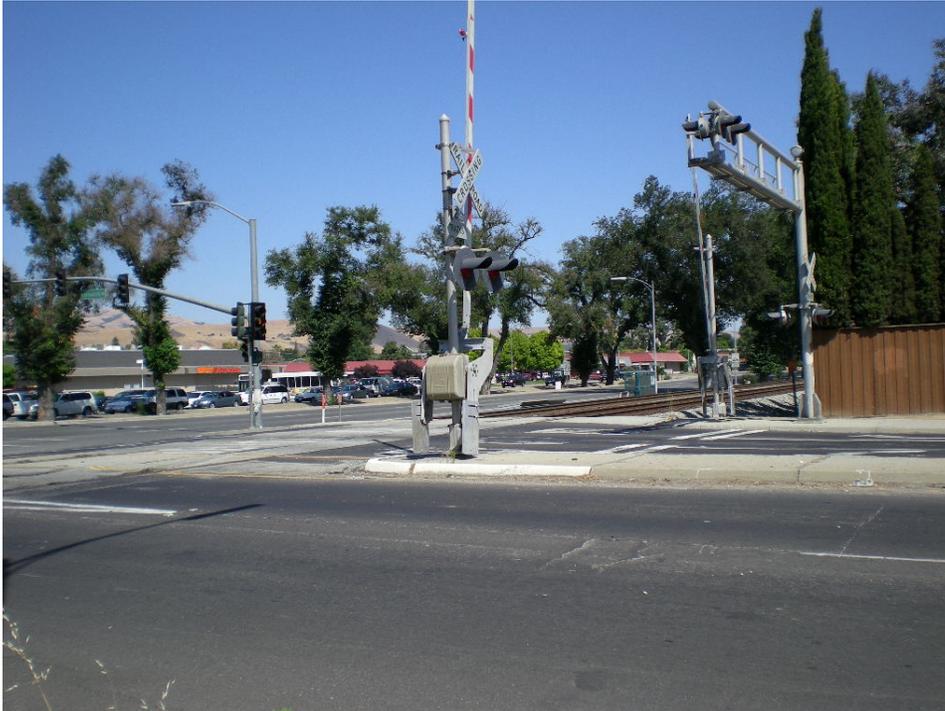
CHYNOWETH AVENUE

<p style="text-align: center;"><u>Northwest Quadrant</u></p> <ul style="list-style-type: none"> ● No Pedestrian Gate ● No Swing Gate ● No Warning Tactiles 		<p style="text-align: center;"><u>Northeast Quadrant</u></p> <ul style="list-style-type: none"> ● No Pedestrian Gate ● No Swing Gate ● No Warning Tactiles
<p style="text-align: center;"><u>Southwest Quadrant</u></p> <ul style="list-style-type: none"> ● No Pedestrian Gate ● No Swing Gates ● No Warning Tactiles 		<p style="text-align: center;"><u>Southeast Quadrant</u></p> <ul style="list-style-type: none"> ● No Pedestrian Gate ● No Swing Gates ● No Warning Tactiles

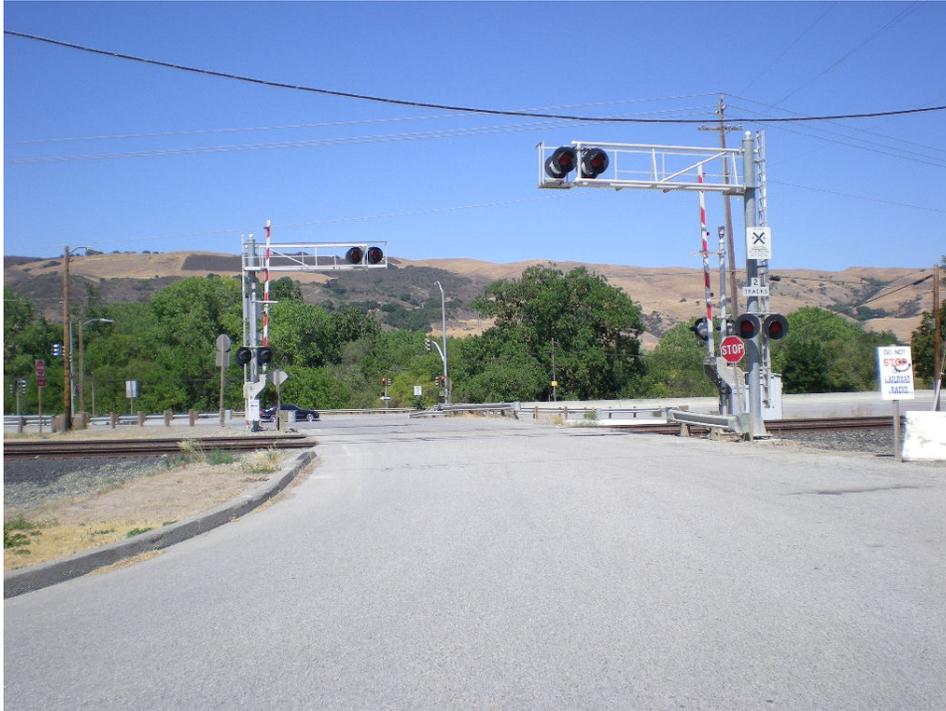
BLANCHARD ROAD

<p style="text-align: center;"><u>Northwest Quadrant</u></p> <ul style="list-style-type: none"> ● No Pedestrian Gate ● No Swing Gate ● No Warning Tactiles ● No Sidewalk 	<p style="text-align: center;"><u>Northeast Quadrant</u></p> <ul style="list-style-type: none"> ● No Pedestrian Gate ● No Swing Gate ● No Warning Tactiles ● No Sidewalk
<p style="text-align: center;"><u>Southwest Quadrant</u></p> <ul style="list-style-type: none"> ● No Pedestrian Gate ● No Swing Gates ● No Warning Tactiles ● No Sidewalk 	<p style="text-align: center;"><u>Southeast Quadrant</u></p> <ul style="list-style-type: none"> ● No Pedestrian Gate ● No Swing Gates ● No Warning Tactiles ● No Sidewalk

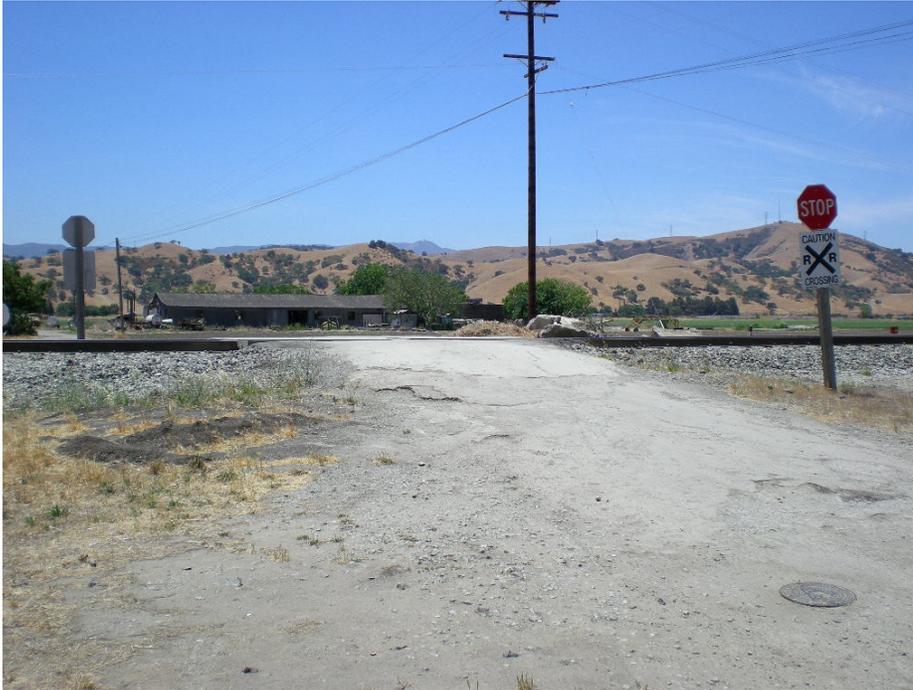
EMADA AVENUE

<p style="text-align: center;"><u>Northwest Quadrant</u></p> <ul style="list-style-type: none"> ● No Pedestrian Gate ● No Swing Gate ● No Warning Tactiles ● No Sidewalk 		<p style="text-align: center;"><u>Northeast Quadrant</u></p> <ul style="list-style-type: none"> ● No Pedestrian Gate ● No Swing Gate ● No Warning Tactiles ● No Sidewalk
<p style="text-align: center;"><u>Southwest Quadrant</u></p> <ul style="list-style-type: none"> ● No Pedestrian Gate ● No Swing Gates ● No Warning Tactiles ● No Sidewalk 		<p style="text-align: center;"><u>Southeast Quadrant</u></p> <ul style="list-style-type: none"> ● No Pedestrian Gate ● No Swing Gates ● No Warning Tactiles ● No Sidewalk

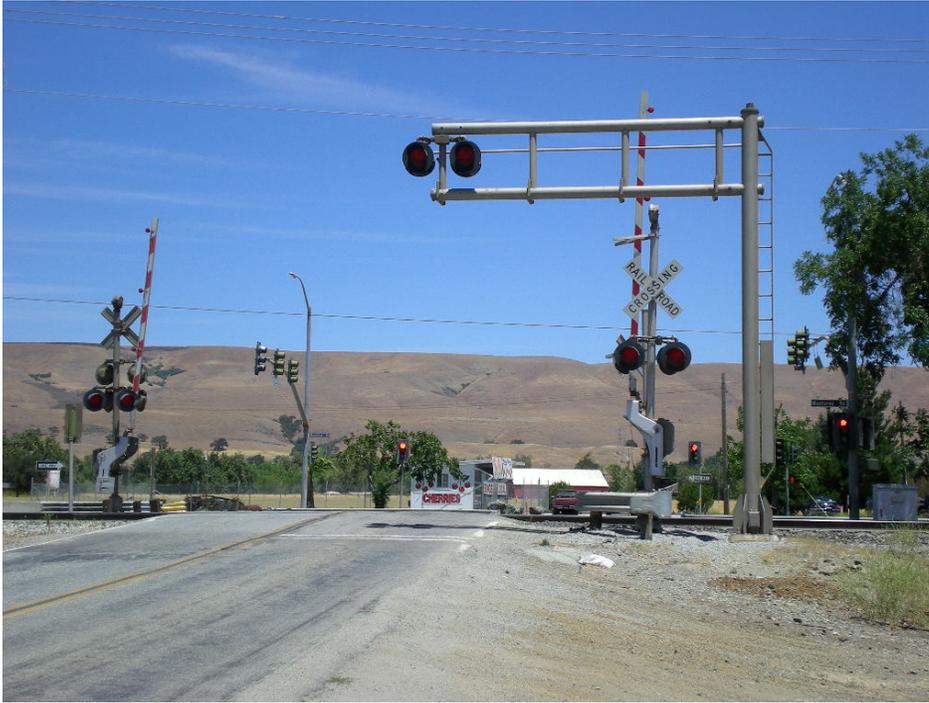
PALM AVENUE

<p style="text-align: center;"><u>Northwest Quadrant</u></p> <ul style="list-style-type: none"> ● No Pedestrian Gate ● No Swing Gate ● No Warning Tactiles ● No Sidewalk 	<p style="text-align: center;"><u>Northeast Quadrant</u></p> <ul style="list-style-type: none"> ● No Pedestrian Gate ● No Swing Gate ● No Warning Tactiles ● No Sidewalk
<p style="text-align: center;"><u>Southwest Quadrant</u></p> <ul style="list-style-type: none"> ● No Pedestrian Gate ● No Swing Gates ● No Warning Tactiles ● No Sidewalk 	<p style="text-align: center;"><u>Southeast Quadrant</u></p> <ul style="list-style-type: none"> ● No Pedestrian Gate ● No Swing Gates ● No Warning Tactiles ● No Sidewalk

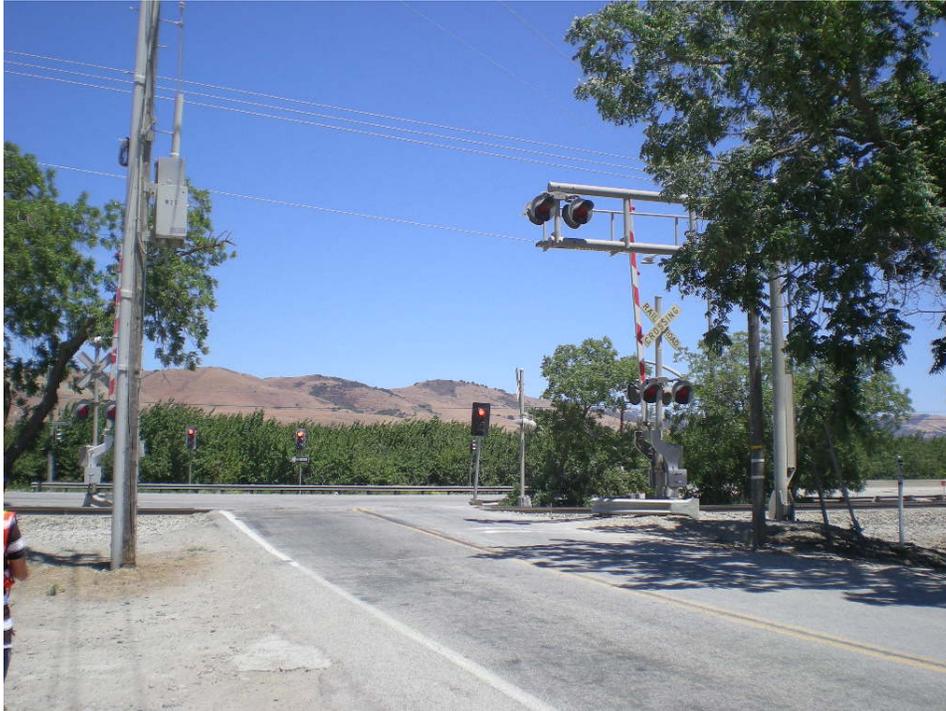
LIVE OAK AVENUE

<p style="text-align: center;"><u>Northwest Quadrant</u></p> <ul style="list-style-type: none"> ● No Pedestrian Gate ● No Swing Gate ● No Warning Tactiles ● No Sidewalk 	<p style="text-align: center;"><u>Northeast Quadrant</u></p> <ul style="list-style-type: none"> ● No Pedestrian Gate ● No Swing Gate ● No Warning Tactiles ● No Sidewalk
<p style="text-align: center;"><u>Southwest Quadrant</u></p> <ul style="list-style-type: none"> ● No Pedestrian Gate ● No Swing Gates ● No Warning Tactiles ● No Sidewalk 	<p style="text-align: center;"><u>Southeast Quadrant</u></p> <ul style="list-style-type: none"> ● No Pedestrian Gate ● No Swing Gates ● No Warning Tactiles ● No Sidewalk

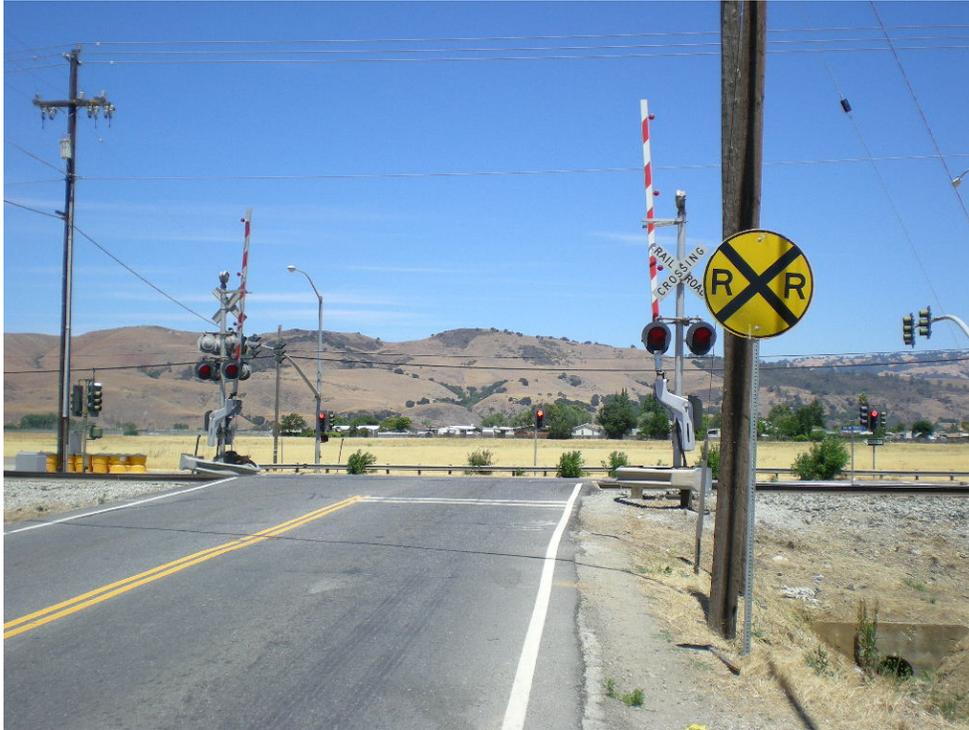
TILTON AVENUE

<p style="text-align: center;"><u>Northwest Quadrant</u></p> <ul style="list-style-type: none"> ● No Pedestrian Gate ● No Swing Gate ● No Warning Tactiles ● No Sidewalk 	<p style="text-align: center;"><u>Northeast Quadrant</u></p> <ul style="list-style-type: none"> ● No Pedestrian Gate ● No Swing Gate ● No Warning Tactiles ● No Sidewalk
<p style="text-align: center;"><u>Southwest Quadrant</u></p> <ul style="list-style-type: none"> ● No Pedestrian Gate ● No Swing Gates ● No Warning Tactiles ● No Sidewalk 	<p style="text-align: center;"><u>Southeast Quadrant</u></p> <ul style="list-style-type: none"> ● No Pedestrian Gate ● No Swing Gates ● No Warning Tactiles ● No Sidewalk

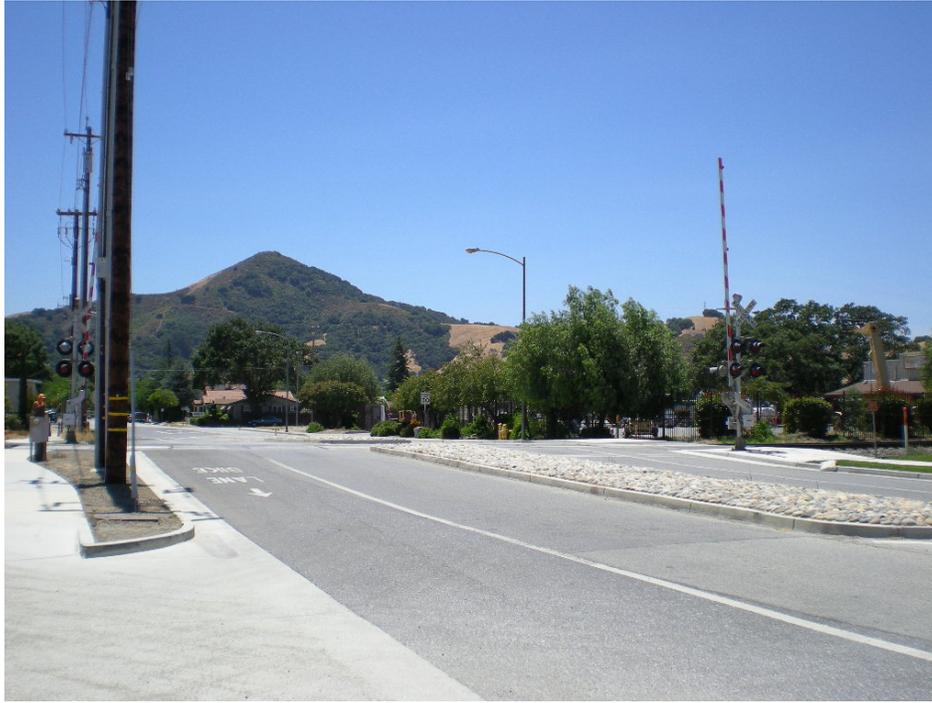
MAIN STREET

<p style="text-align: center;"><u>Northwest Quadrant</u></p> <ul style="list-style-type: none"> ● No Pedestrian Gate ● No Swing Gate ● No Warning Tactiles 	<p style="text-align: center;"><u>Northeast Quadrant</u></p> <ul style="list-style-type: none"> ● No Pedestrian Gate ● No Swing Gate ● No Warning Tactiles
<p style="text-align: center;"><u>Southwest Quadrant</u></p> <ul style="list-style-type: none"> ● No Pedestrian Gate ● No Swing Gates ● No Warning Tactiles 	<p style="text-align: center;"><u>Southeast Quadrant</u></p> <ul style="list-style-type: none"> ● No Pedestrian Gate ● No Swing Gates ● No Warning Tactiles

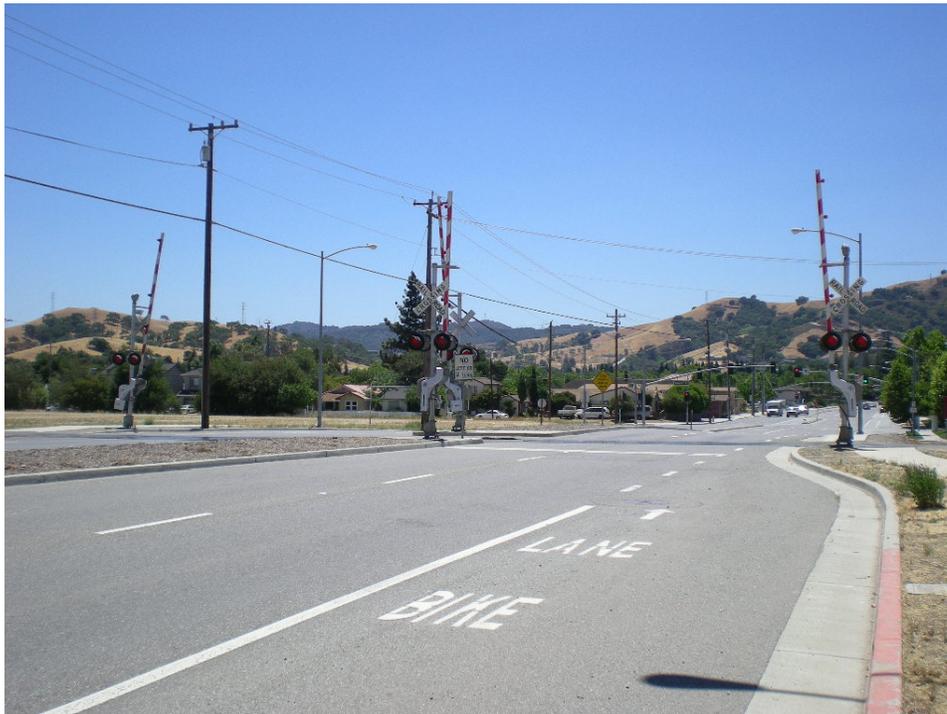
DUNNE STREET

<p style="text-align: center;"><u>Northwest Quadrant</u></p> <ul style="list-style-type: none"> ● No Pedestrian Gate ● No Swing Gate ● No Warning Tactiles 	<p style="text-align: center;"><u>Northeast Quadrant</u></p> <ul style="list-style-type: none"> ● No Pedestrian Gate ● No Swing Gate ● No Warning Tactiles
<p style="text-align: center;"><u>Southwest Quadrant</u></p> <ul style="list-style-type: none"> ● No Pedestrian Gate ● No Swing Gates ● No Warning Tactiles 	<p style="text-align: center;"><u>Southeast Quadrant</u></p> <ul style="list-style-type: none"> ● No Pedestrian Gate ● No Swing Gates ● No Warning Tactiles

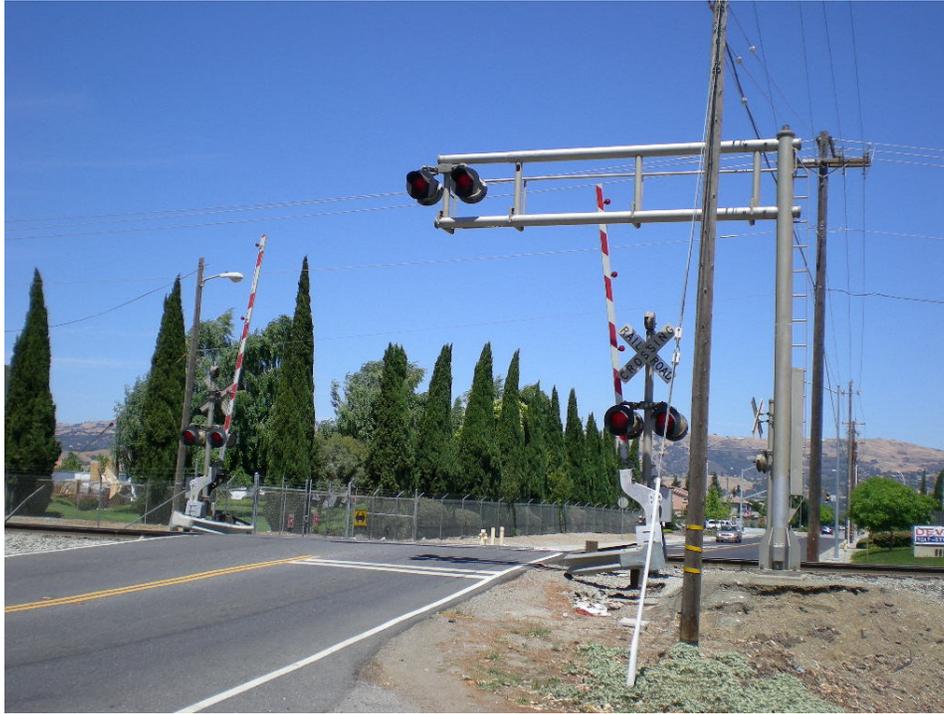
SAN PEDRO AVENUE

<p style="text-align: center;"><u>Northwest Quadrant</u></p> <ul style="list-style-type: none"> ● No Pedestrian Gate ● No Swing Gate ● No Warning Tactiles 	<p style="text-align: center;"><u>Northeast Quadrant</u></p> <ul style="list-style-type: none"> ● No Pedestrian Gate ● No Swing Gate ● No Warning Tactiles
<p style="text-align: center;"><u>Southwest Quadrant</u></p> <ul style="list-style-type: none"> ● No Pedestrian Gate ● No Swing Gates ● No Warning Tactiles 	<p style="text-align: center;"><u>Southeast Quadrant</u></p> <ul style="list-style-type: none"> ● No Pedestrian Gate ● No Swing Gates ● No Warning Tactiles

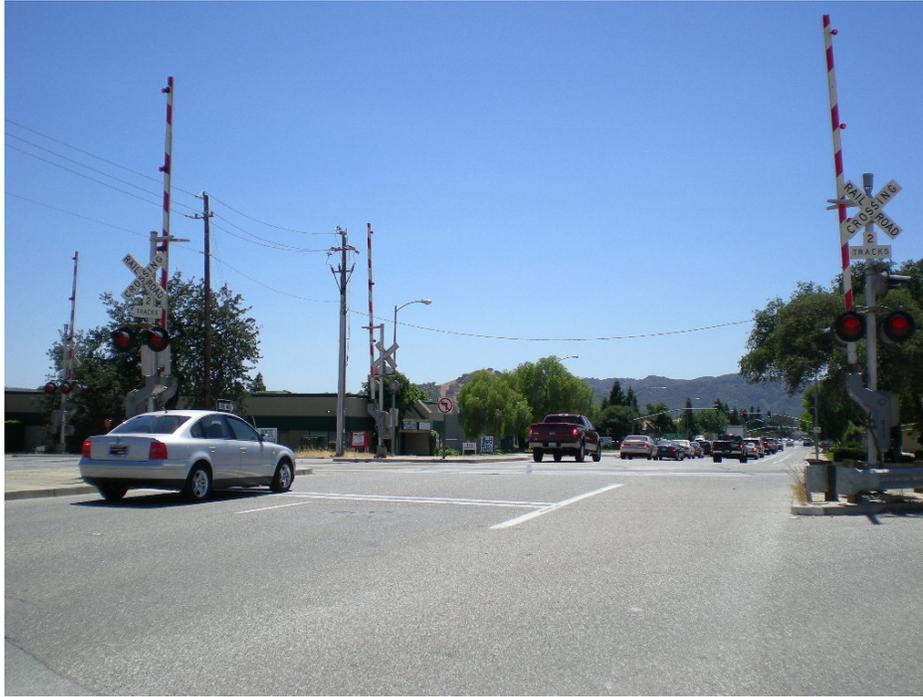
TENNANT AVENUE

<p style="text-align: center;"><u>Northwest Quadrant</u></p> <ul style="list-style-type: none"> ● No Pedestrian Gate ● No Swing Gate ● No Warning Tactiles 	<p style="text-align: center;"><u>Northeast Quadrant</u></p> <ul style="list-style-type: none"> ● No Pedestrian Gate ● No Swing Gate ● No Warning Tactiles
<p style="text-align: center;"><u>Southwest Quadrant</u></p> <ul style="list-style-type: none"> ● No Pedestrian Gate ● No Swing Gates ● No Warning Tactiles 	<p style="text-align: center;"><u>Southeast Quadrant</u></p> <ul style="list-style-type: none"> ● No Pedestrian Gate ● No Swing Gates ● No Warning Tactiles

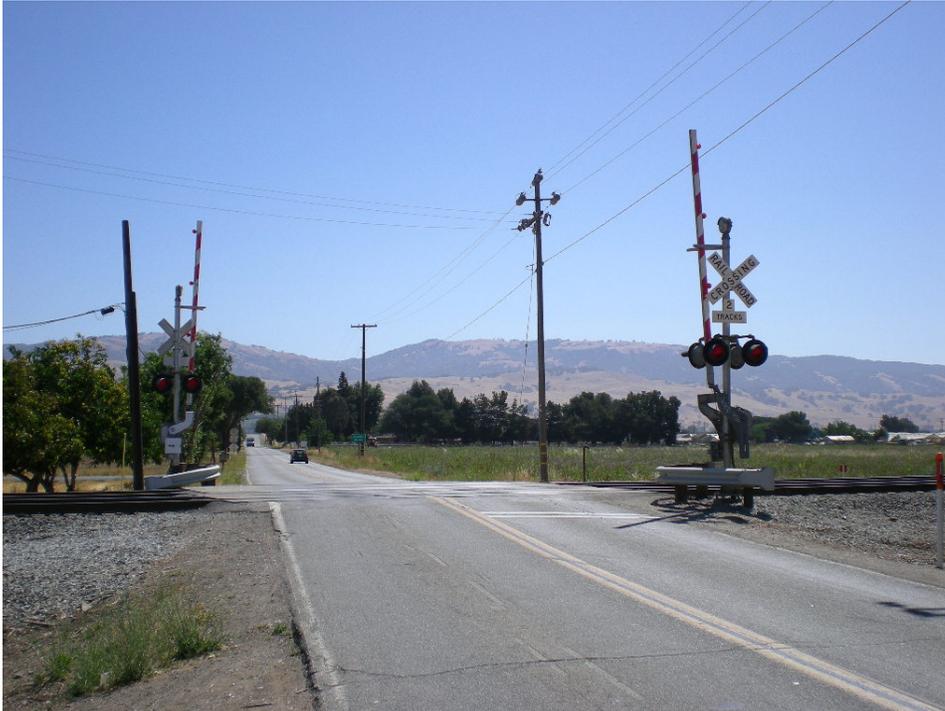
EAST MIDDLE AVENUE

<p style="text-align: center;"><u>Northwest Quadrant</u></p> <ul style="list-style-type: none"> ● No Pedestrian Gate ● No Swing Gate ● No Warning Tactiles 		<p style="text-align: center;"><u>Northeast Quadrant</u></p> <ul style="list-style-type: none"> ● No Pedestrian Gate ● No Swing Gate ● No Warning Tactiles
<p style="text-align: center;"><u>Southwest Quadrant</u></p> <ul style="list-style-type: none"> ● No Pedestrian Gate ● No Swing Gates ● No Warning Tactiles 		<p style="text-align: center;"><u>Southeast Quadrant</u></p> <ul style="list-style-type: none"> ● No Pedestrian Gate ● No Swing Gates ● No Warning Tactiles

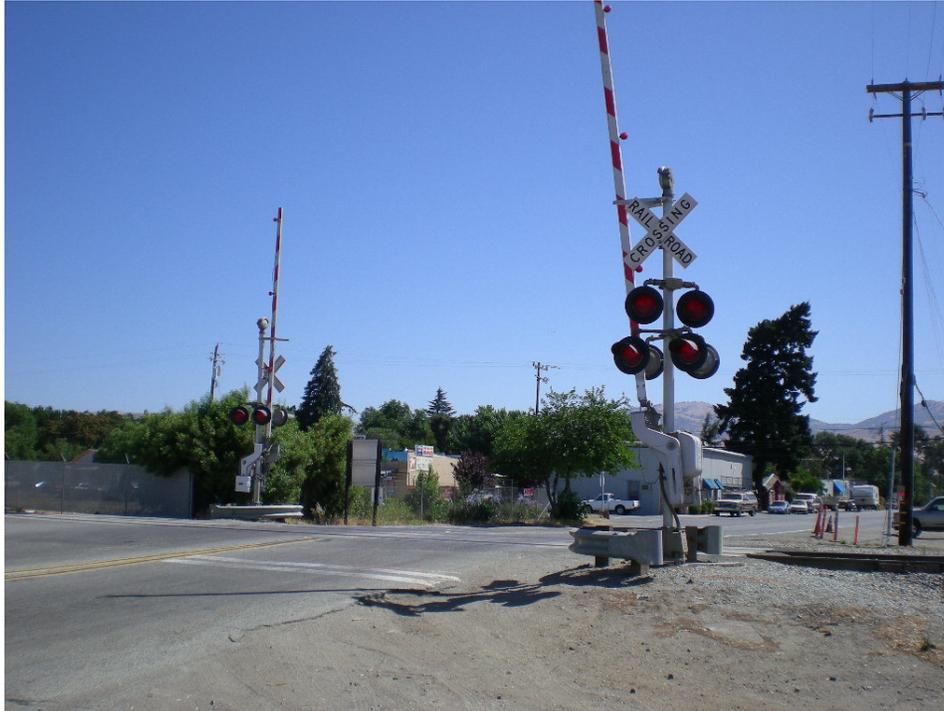
SAN MARTIN AVENUE

<p style="text-align: center;"><u>Northwest Quadrant</u></p> <ul style="list-style-type: none"> ● No Pedestrian Gate ● No Swing Gate ● No Warning Tactiles 	<p style="text-align: center;"><u>Northeast Quadrant</u></p> <ul style="list-style-type: none"> ● No Pedestrian Gate ● No Swing Gate ● No Warning Tactiles
<p style="text-align: center;"><u>Southwest Quadrant</u></p> <ul style="list-style-type: none"> ● No Pedestrian Gate ● No Swing Gates ● No Warning Tactiles 	<p style="text-align: center;"><u>Southeast Quadrant</u></p> <ul style="list-style-type: none"> ● No Pedestrian Gate ● No Swing Gates ● No Warning Tactiles

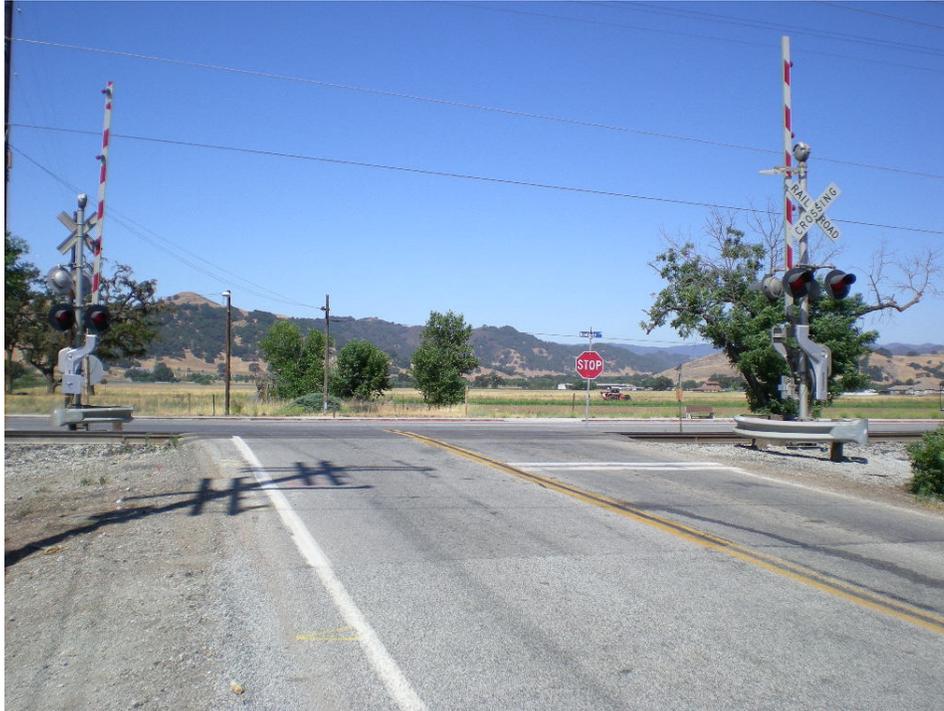
CHURCH AVENUE

<p style="text-align: center;"><u>Northwest Quadrant</u></p> <ul style="list-style-type: none"> ● No Pedestrian Gate ● No Swing Gate ● No Warning Tactiles 	<p style="text-align: center;"><u>Northeast Quadrant</u></p> <ul style="list-style-type: none"> ● No Pedestrian Gate ● No Swing Gate ● No Warning Tactiles
<p style="text-align: center;"><u>Southwest Quadrant</u></p> <ul style="list-style-type: none"> ● No Pedestrian Gate ● No Swing Gates ● No Warning Tactiles 	<p style="text-align: center;"><u>Southeast Quadrant</u></p> <ul style="list-style-type: none"> ● No Pedestrian Gate ● No Swing Gates ● No Warning Tactiles
