CONSOLIDATED SAFETY STUDY FOR CALTRAIN IN SANTA CLARA COUNTY

Executive Summary

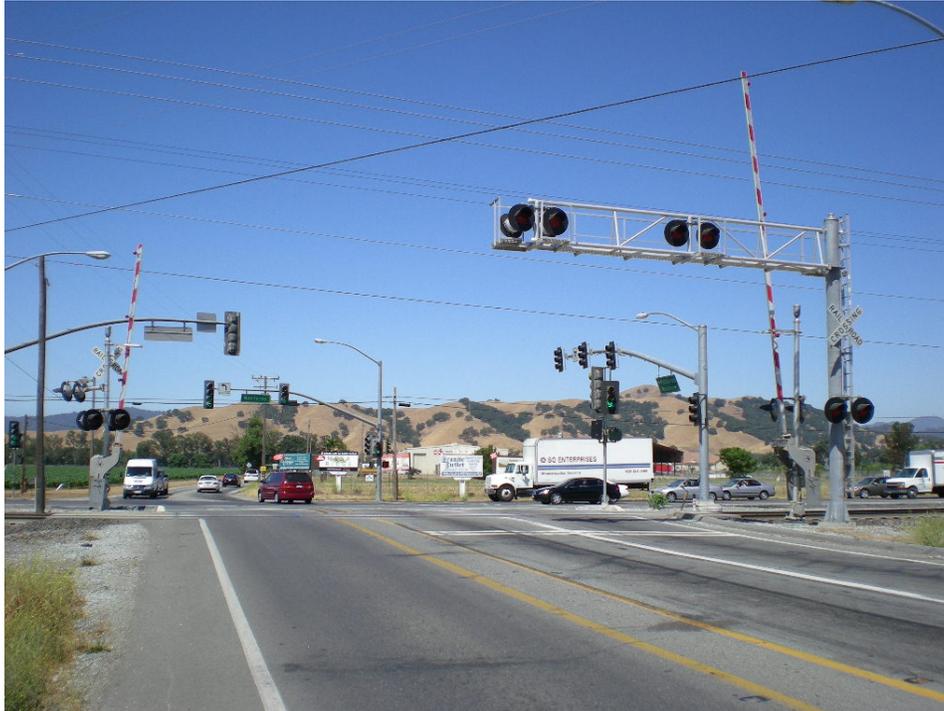
MASTEN AVENUE

<p style="text-align: center;"><u>Northwest Quadrant</u></p> <ul style="list-style-type: none"> ● No Pedestrian Gate ● No Swing Gate ● No Warning Tactiles 		<p style="text-align: center;"><u>Northeast Quadrant</u></p> <ul style="list-style-type: none"> ● No Pedestrian Gate ● No Swing Gate ● No Warning Tactiles
<p style="text-align: center;"><u>Southwest Quadrant</u></p> <ul style="list-style-type: none"> ● No Pedestrian Gate ● No Swing Gates ● No Warning Tactiles 		<p style="text-align: center;"><u>Southeast Quadrant</u></p> <ul style="list-style-type: none"> ● No Pedestrian Gate ● No Swing Gates ● No Warning Tactiles

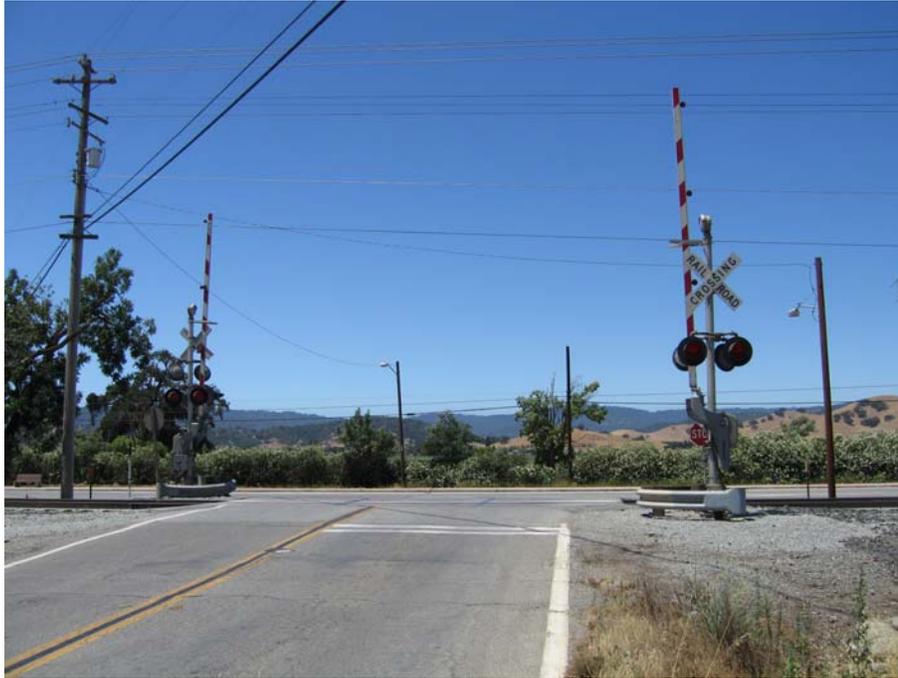
RUCKER AVENUE

<p style="text-align: center;"><u>Northwest Quadrant</u></p> <ul style="list-style-type: none"> ● No Pedestrian Gate ● No Swing Gate ● No Warning Tactiles 		<p style="text-align: center;"><u>Northeast Quadrant</u></p> <ul style="list-style-type: none"> ● No Pedestrian Gate ● No Swing Gate ● No Warning Tactiles
<p style="text-align: center;"><u>Southwest Quadrant</u></p> <ul style="list-style-type: none"> ● No Pedestrian Gate ● No Swing Gates ● No Warning Tactiles 		<p style="text-align: center;"><u>Southeast Quadrant</u></p> <ul style="list-style-type: none"> ● No Pedestrian Gate ● No Swing Gates ● No Warning Tactiles

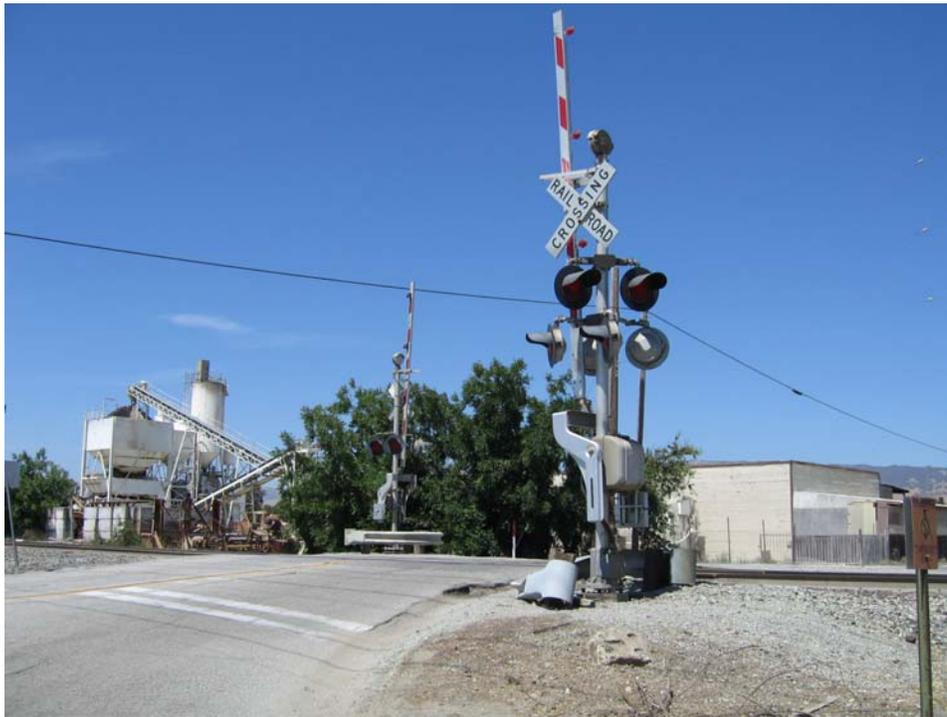
BUENA VISTA AVENUE

<p style="text-align: center;"><u>Northwest Quadrant</u></p> <ul style="list-style-type: none"> ● No Pedestrian Gate ● No Swing Gate ● No Warning Tactiles 	<p style="text-align: center;"><u>Northeast Quadrant</u></p> <ul style="list-style-type: none"> ● No Pedestrian Gate ● No Swing Gate ● No Warning Tactiles
<p style="text-align: center;"><u>Southwest Quadrant</u></p> <ul style="list-style-type: none"> ● No Pedestrian Gate ● No Swing Gates ● No Warning Tactiles 	<p style="text-align: center;"><u>Southeast Quadrant</u></p> <ul style="list-style-type: none"> ● No Pedestrian Gate ● No Swing Gates ● No Warning Tactiles

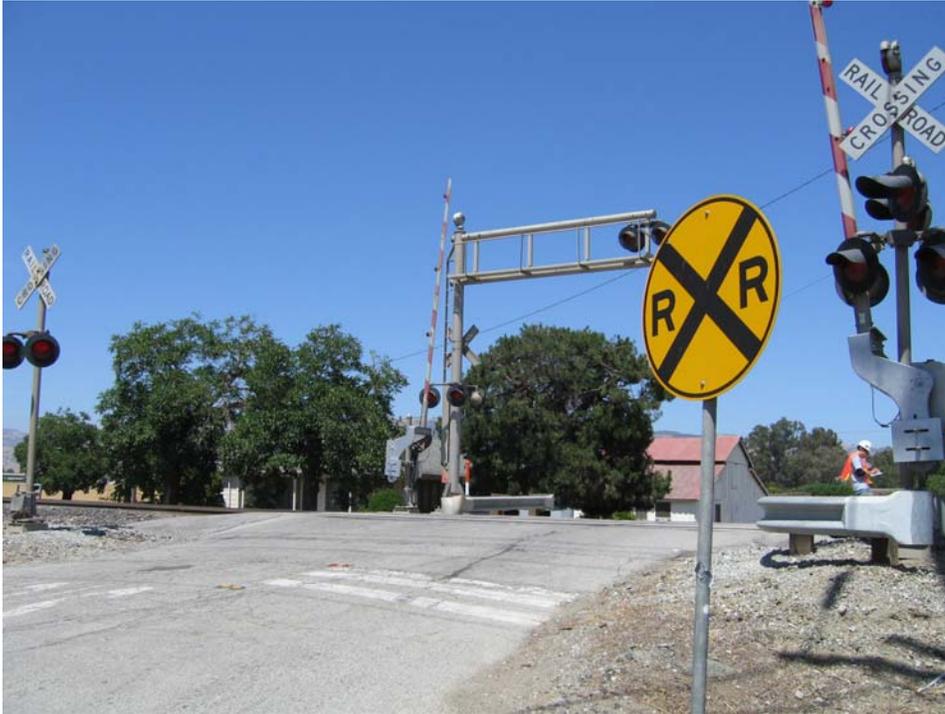
COHANSEY AVENUE

<p style="text-align: center;"><u>Northwest Quadrant</u></p> <ul style="list-style-type: none"> ● No Pedestrian Gate ● No Swing Gate ● No Warning Tactiles 	<p style="text-align: center;"><u>Northeast Quadrant</u></p> <ul style="list-style-type: none"> ● No Pedestrian Gate ● No Swing Gate ● No Warning Tactiles
<p style="text-align: center;"><u>Southwest Quadrant</u></p> <ul style="list-style-type: none"> ● No Pedestrian Gate ● No Swing Gates ● No Warning Tactiles 	<p style="text-align: center;"><u>Southeast Quadrant</u></p> <ul style="list-style-type: none"> ● No Pedestrian Gate ● No Swing Gates ● No Warning Tactiles

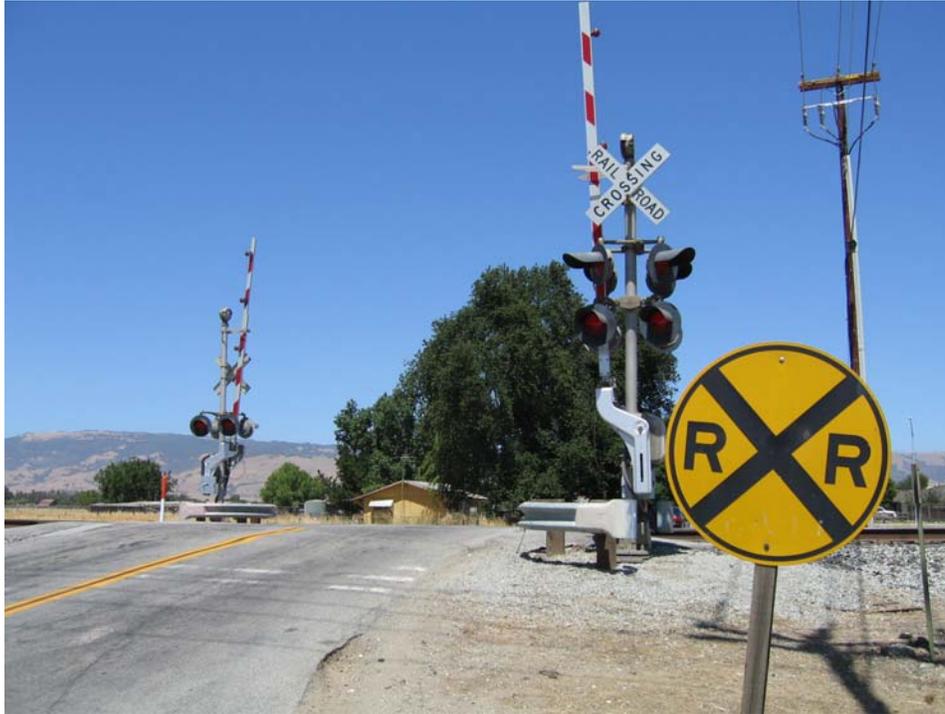
LAS ANIMAS AVENUE

<p style="text-align: center;"><u>Northwest Quadrant</u></p> <ul style="list-style-type: none"> ● No Pedestrian Gate ● No Swing Gate ● No Warning Tactiles 	<p style="text-align: center;"><u>Northeast Quadrant</u></p> <ul style="list-style-type: none"> ● No Pedestrian Gate ● No Swing Gate ● No Warning Tactiles
<p style="text-align: center;"><u>Southwest Quadrant</u></p> <ul style="list-style-type: none"> ● No Pedestrian Gate ● No Swing Gates ● No Warning Tactiles 	<p style="text-align: center;"><u>Southeast Quadrant</u></p> <ul style="list-style-type: none"> ● No Pedestrian Gate ● No Swing Gates ● No Warning Tactiles

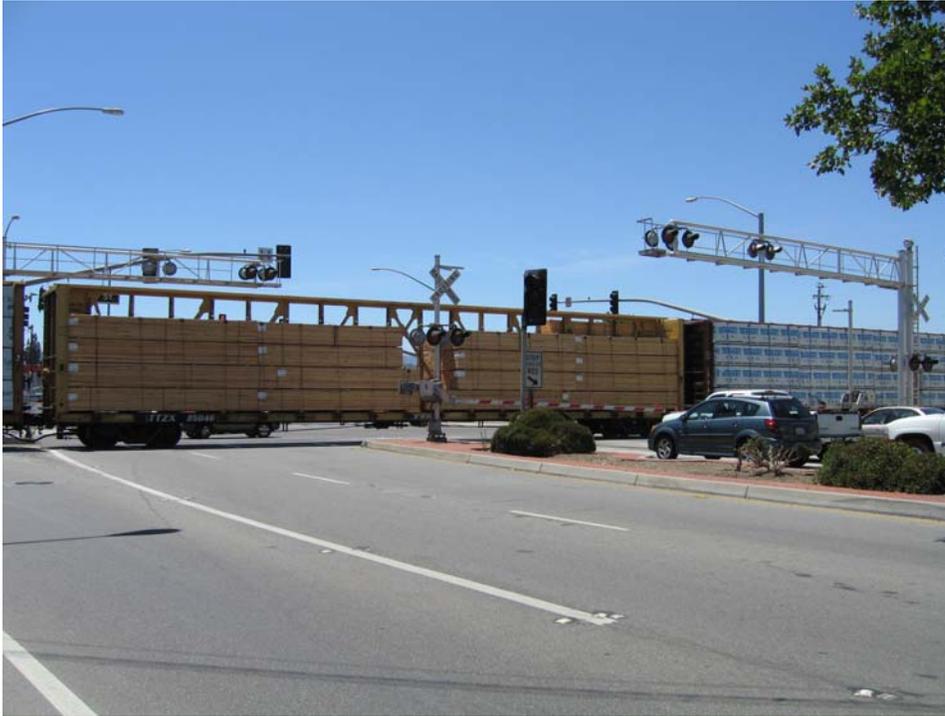
LEAVESLEY ROAD

<p style="text-align: center;"><u>Northwest Quadrant</u></p> <ul style="list-style-type: none"> ● No Pedestrian Gate ● No Swing Gate ● No Warning Tactiles 		<p style="text-align: center;"><u>Northeast Quadrant</u></p> <ul style="list-style-type: none"> ● No Pedestrian Gate ● No Swing Gate ● No Warning Tactiles
<p style="text-align: center;"><u>Southwest Quadrant</u></p> <ul style="list-style-type: none"> ● No Pedestrian Gate ● No Swing Gates ● No Warning Tactiles 		<p style="text-align: center;"><u>Southeast Quadrant</u></p> <ul style="list-style-type: none"> ● No Pedestrian Gate ● No Swing Gates ● No Warning Tactiles

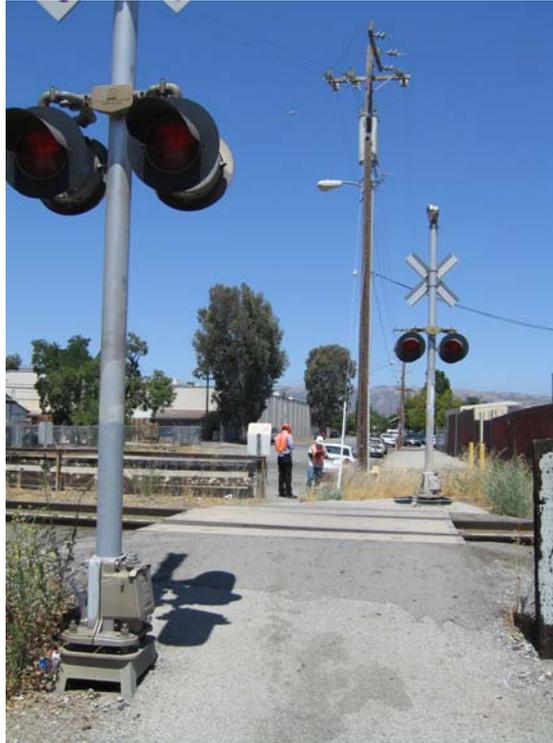
CASEY ROAD

<p style="text-align: center;"><u>Northwest Quadrant</u></p> <ul style="list-style-type: none"> ● No Pedestrian Gate ● No Swing Gate ● No Warning Tactiles 	<p style="text-align: center;"><u>Northeast Quadrant</u></p> <ul style="list-style-type: none"> ● No Pedestrian Gate ● No Swing Gate ● No Warning Tactiles
<p style="text-align: center;"><u>Southwest Quadrant</u></p> <ul style="list-style-type: none"> ● No Pedestrian Gate ● No Swing Gates ● No Warning Tactiles 	<p style="text-align: center;"><u>Southeast Quadrant</u></p> <ul style="list-style-type: none"> ● No Pedestrian Gate ● No Swing Gates ● No Warning Tactiles

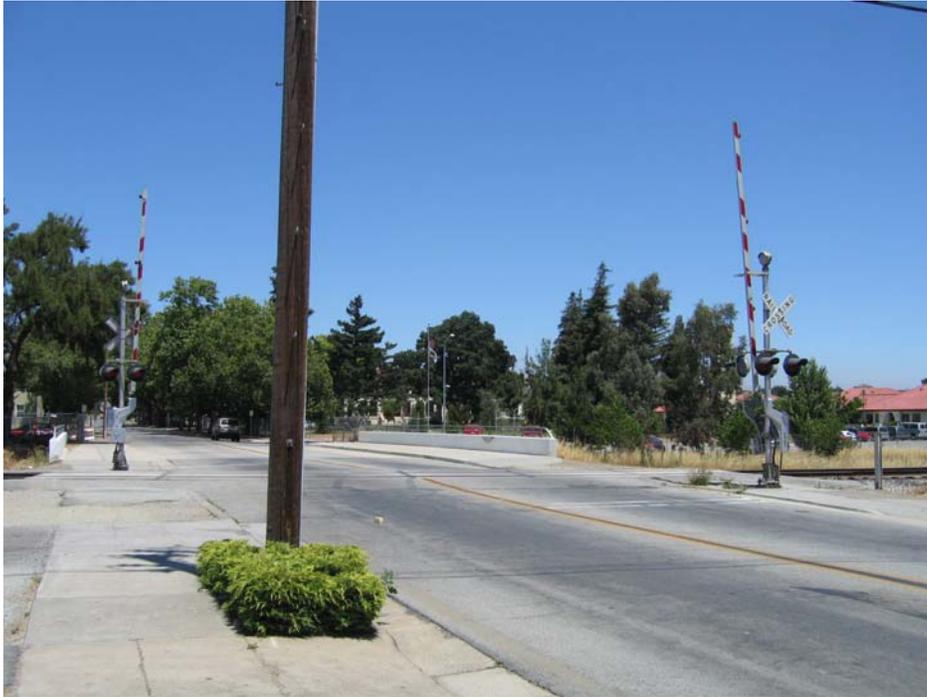
IOOF AVENUE

<p style="text-align: center;"><u>Northwest Quadrant</u></p> <ul style="list-style-type: none"> ● No Pedestrian Gate ● No Swing Gate ● No Warning Tactiles 		<p style="text-align: center;"><u>Northeast Quadrant</u></p> <ul style="list-style-type: none"> ● No Pedestrian Gate ● No Swing Gate ● No Warning Tactiles
<p style="text-align: center;"><u>Southwest Quadrant</u></p> <ul style="list-style-type: none"> ● No Pedestrian Gate ● No Swing Gates ● No Warning Tactiles 		<p style="text-align: center;"><u>Southeast Quadrant</u></p> <ul style="list-style-type: none"> ● No Pedestrian Gate ● No Swing Gates ● No Warning Tactiles

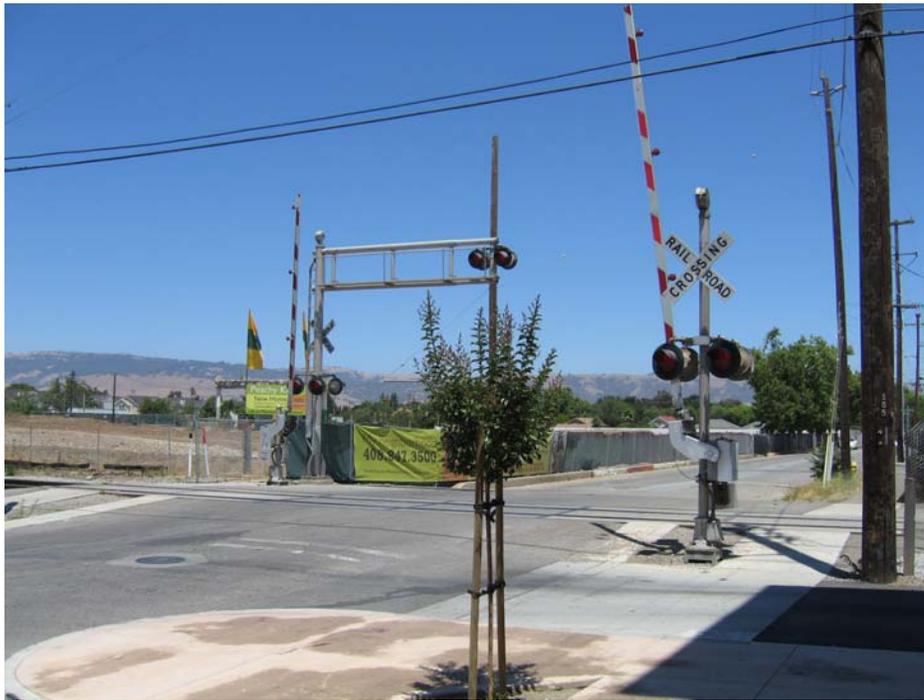
LEWIS STREET

<p style="text-align: center;"><u>Northwest Quadrant</u></p> <ul style="list-style-type: none"> ● No Pedestrian Gate ● No Swing Gate ● No Warning Tactiles 	<p style="text-align: center;"><u>Northeast Quadrant</u></p> <ul style="list-style-type: none"> ● No Pedestrian Gate ● No Swing Gate ● No Warning Tactiles
<p style="text-align: center;"><u>Southwest Quadrant</u></p> <ul style="list-style-type: none"> ● No Pedestrian Gate ● No Swing Gates ● No Warning Tactiles 	<p style="text-align: center;"><u>Southeast Quadrant</u></p> <ul style="list-style-type: none"> ● No Pedestrian Gate ● No Swing Gates ● No Warning Tactiles

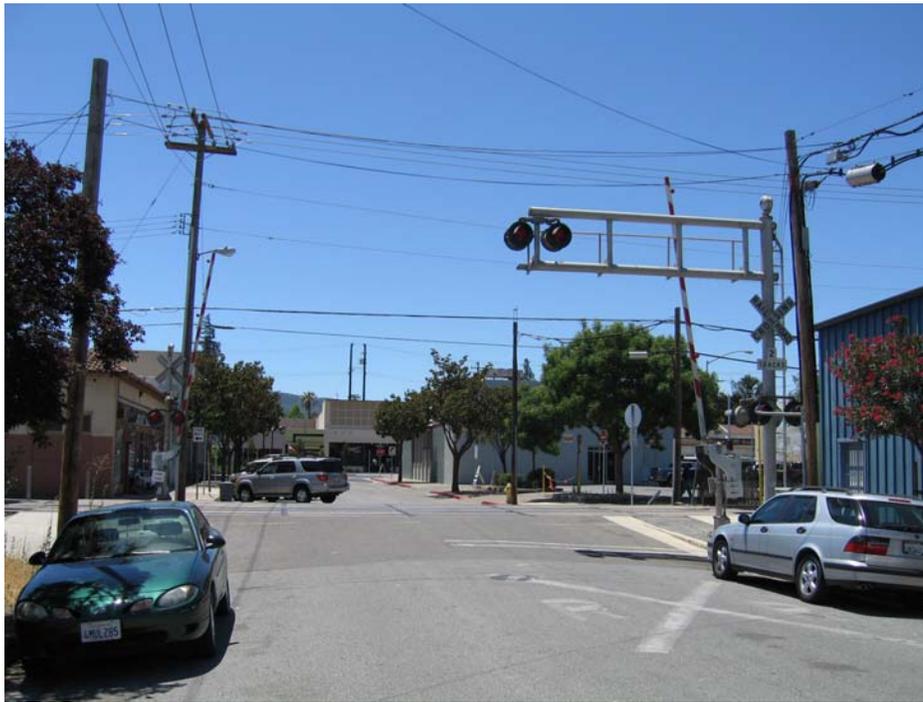
MARTIN STREET

<p style="text-align: center;"><u>Northwest Quadrant</u></p> <ul style="list-style-type: none"> ● No Pedestrian Gate ● No Swing Gate ● No Warning Tactiles 	<p style="text-align: center;"><u>Northeast Quadrant</u></p> <ul style="list-style-type: none"> ● No Pedestrian Gate ● No Swing Gate ● No Warning Tactiles ● Trees and Power Pole obstruct visibility
<p style="text-align: center;"><u>Southwest Quadrant</u></p> <ul style="list-style-type: none"> ● No Pedestrian Gate ● No Swing Gates ● No Warning Tactiles ● Power Pole obstructs visibility 	<p style="text-align: center;"><u>Southeast Quadrant</u></p> <ul style="list-style-type: none"> ● No Pedestrian Gate ● No Swing Gates ● No Warning Tactiles

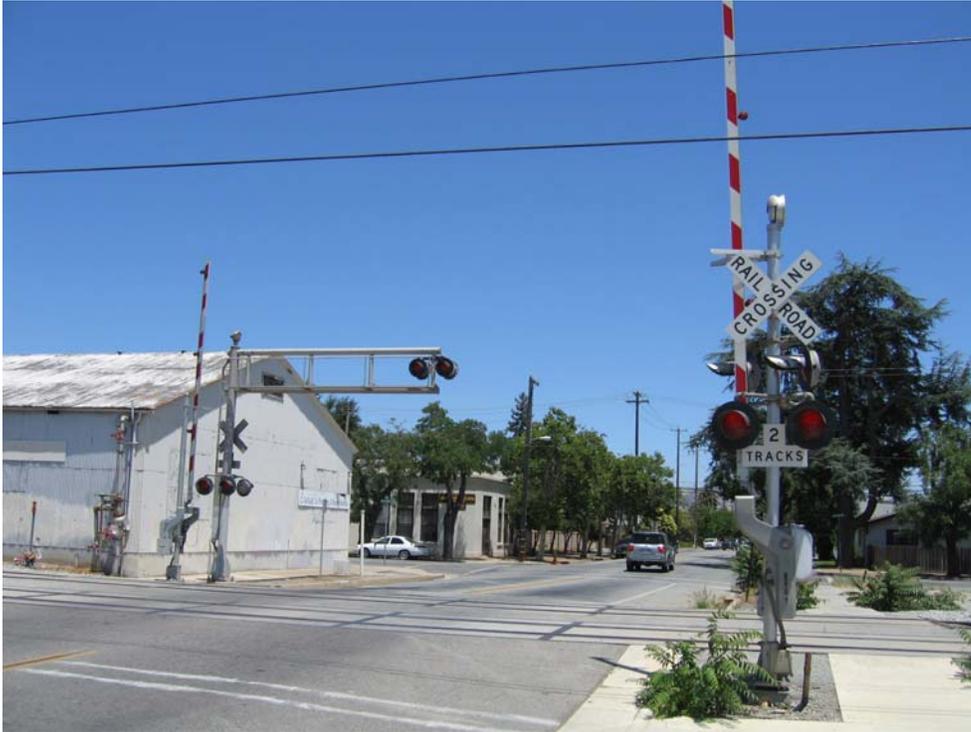
6TH STREET

<p style="text-align: center;"><u>Northwest Quadrant</u></p> <ul style="list-style-type: none"> ● No Pedestrian Gate ● No Swing Gate ● No Warning Tactiles 	<p style="text-align: center;"><u>Northeast Quadrant</u></p> <ul style="list-style-type: none"> ● No Pedestrian Gate ● No Swing Gate ● No Warning Tactiles
<p style="text-align: center;"><u>Southwest Quadrant</u></p> <ul style="list-style-type: none"> ● No Pedestrian Gate ● No Swing Gates ● No Warning Tactiles 	<p style="text-align: center;"><u>Southeast Quadrant</u></p> <ul style="list-style-type: none"> ● No Pedestrian Gate ● No Swing Gates ● No Warning Tactiles

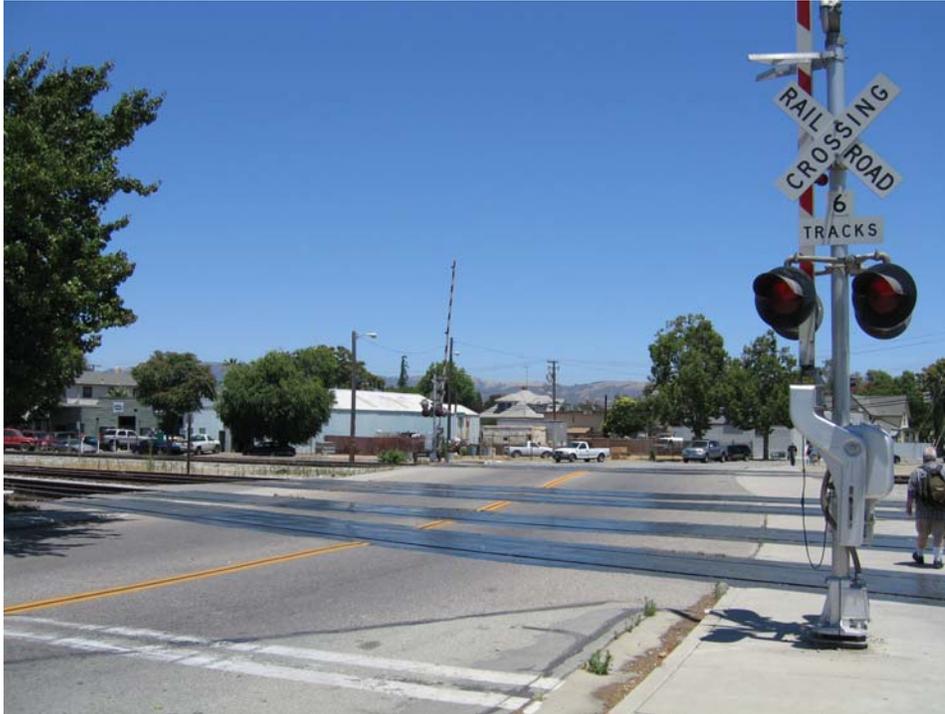
7TH STREET

<p style="text-align: center;"><u>Northwest Quadrant</u></p> <ul style="list-style-type: none"> ● No Pedestrian Gate ● No Swing Gate ● No Warning Tactiles 	<p style="text-align: center;"><u>Northeast Quadrant</u></p> <ul style="list-style-type: none"> ● No Pedestrian Gate ● No Swing Gate ● No Warning Tactiles
<p style="text-align: center;"><u>Southwest Quadrant</u></p> <ul style="list-style-type: none"> ● No Pedestrian Gate ● No Swing Gates ● No Warning Tactiles 	<p style="text-align: center;"><u>Southeast Quadrant</u></p> <ul style="list-style-type: none"> ● No Pedestrian Gate ● No Swing Gates ● No Warning Tactiles

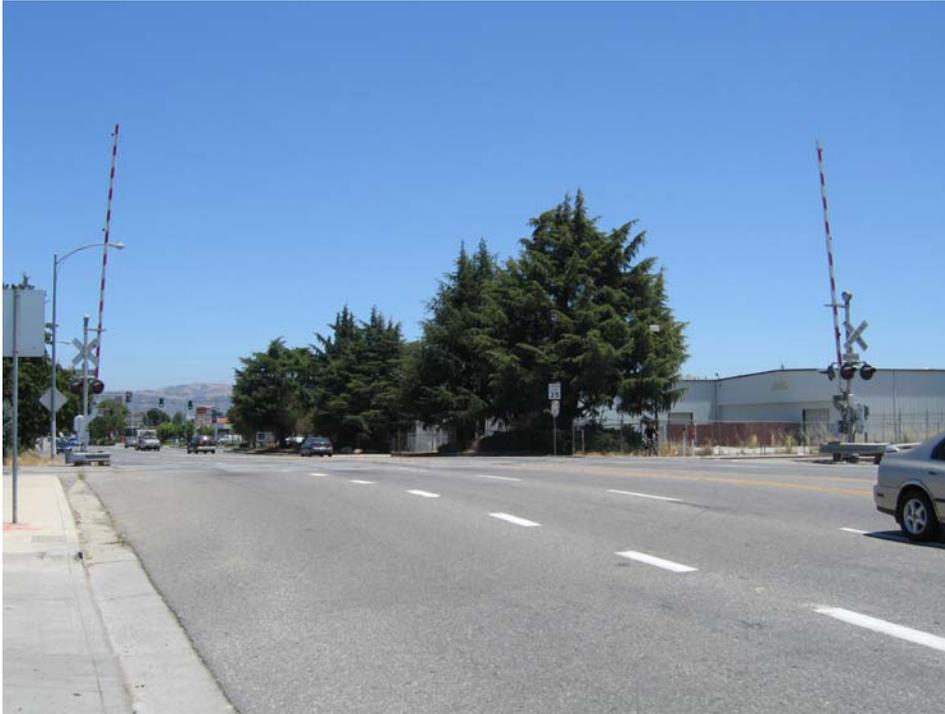
10TH STREET

<p style="text-align: center;"><u>Northwest Quadrant</u></p> <ul style="list-style-type: none"> ● No Pedestrian Gate ● No Swing Gate ● No Warning Tactiles 		<p style="text-align: center;"><u>Northeast Quadrant</u></p> <ul style="list-style-type: none"> ● No Pedestrian Gate ● No Swing Gate ● No Warning Tactiles
<p style="text-align: center;"><u>Southwest Quadrant</u></p> <ul style="list-style-type: none"> ● No Pedestrian Gate ● No Swing Gates ● No Warning Tactiles 		<p style="text-align: center;"><u>Southeast Quadrant</u></p> <ul style="list-style-type: none"> ● No Pedestrian Gate ● No Swing Gates ● No Warning Tactiles
